Notice is hereby given that the INFRASTRUCTURE AND FACILITIES COMMITTEE of the City of Wausau, Wisconsin will hold a regular or special meeting on the date, time and location shown below.

| Meeting of the: | <b>INFRASTRUCTURE AND FACILITIES COMMITTEE OF THE CITY OF WAUSAU</b> |
| Date/Time: | <b>Thursday, August 8, 2024 at 5:15 p.m.</b> |

Update/Presentation by Becher Hoppe on the street and utility portion of the Wausau Mall Redevelopment Project

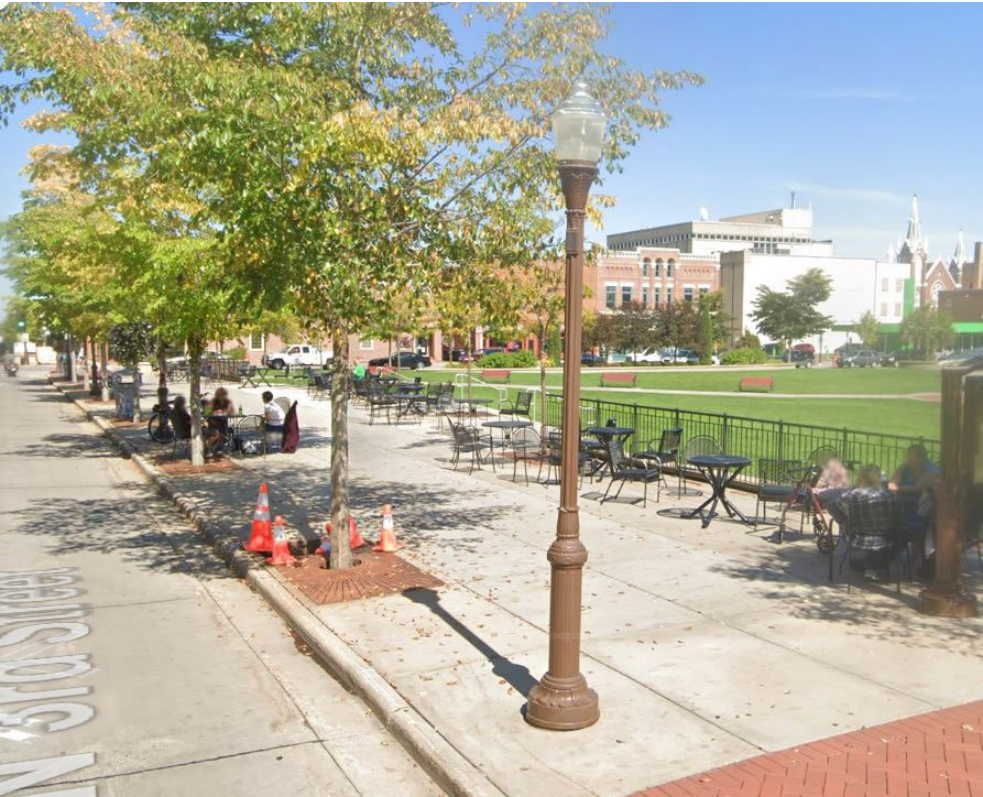
# Downtown Wausau Mall Design Development Plan - Street Lighting

Existing Street Light Standard - converted to LED

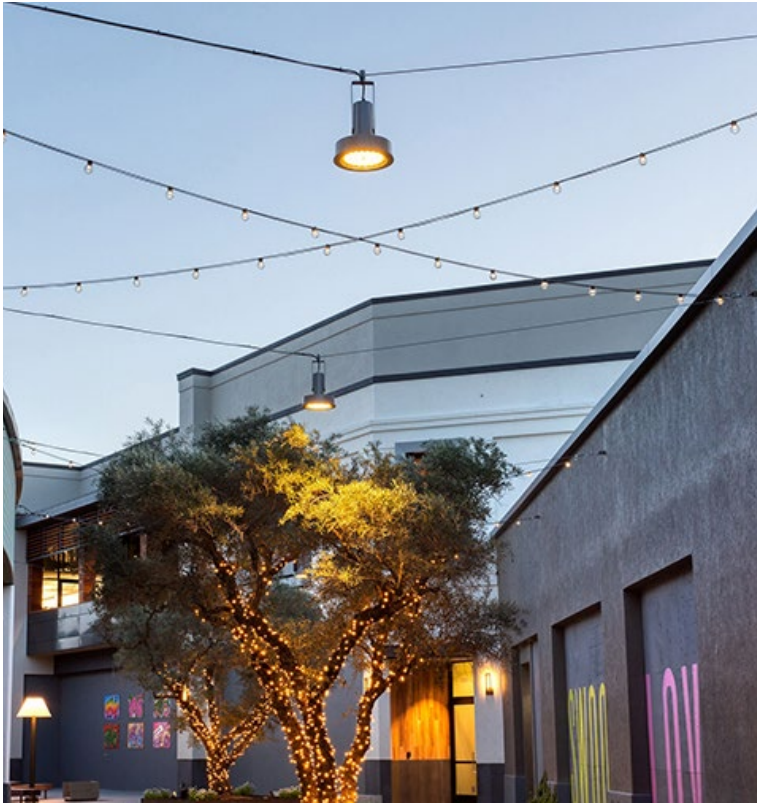
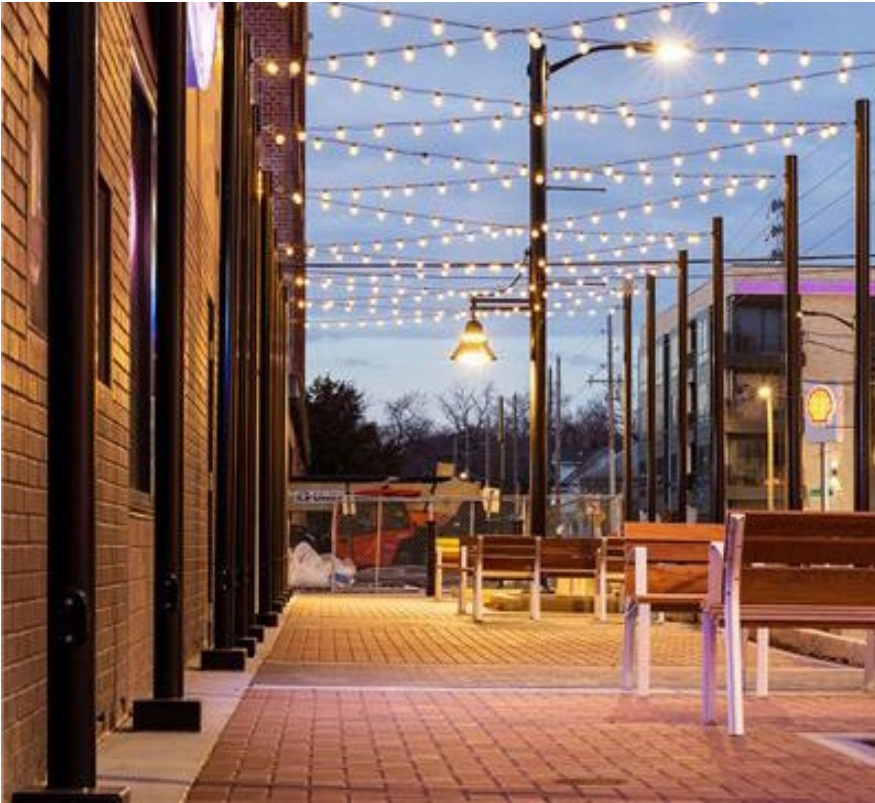
Overhead Caternary Lighting and Receptacles in Tree Planters

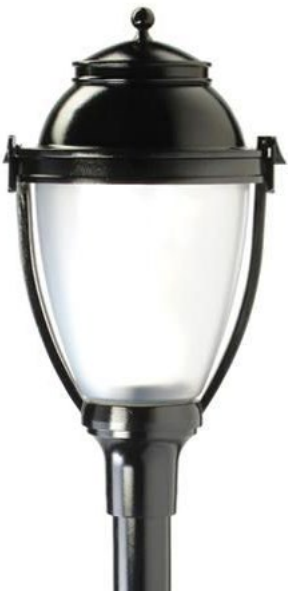
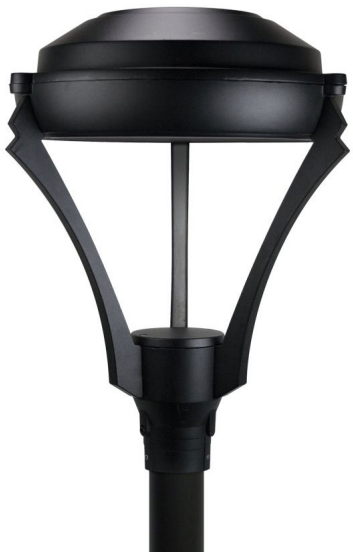
Contemporary LED Post-top Luminaire

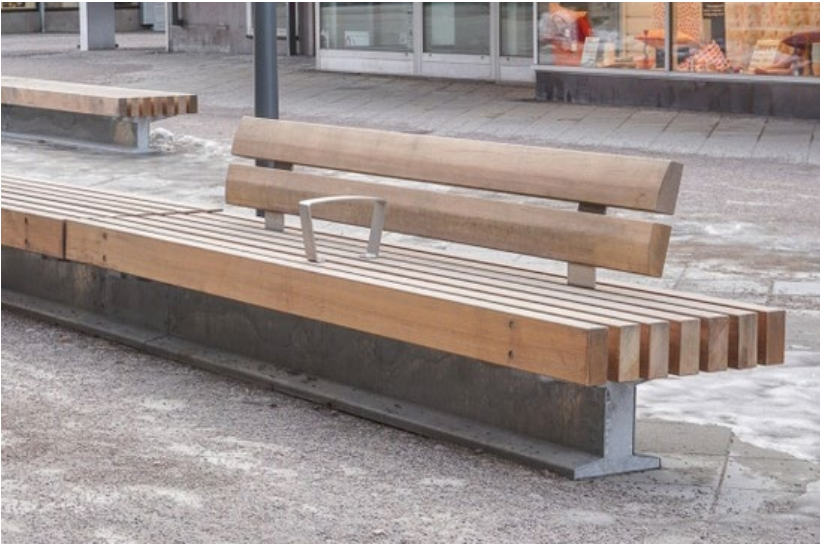
# Downtown Wausau Mall Design Development Plan - Amenities and Furnishings

Example of Wood and Steel Bench
