## OFFICIAL NOTICE AND AGENDA

Meeting of the: **PARKS AND RECREATION COMMITTEE OF THE CITY OF WAUSAU**  
Date/Time: **Monday, April 3, 2023 at 4:30pm**  
Location: **1703 Cherry Street for EAB review then to City Hall (407 Grant St, Wausau WI 54403) - Council Chambers**  
Members: **Dawn Herbst, Carol Lukens, Tom Kilian, Lou Larson, Sarah Watson**

## March Update

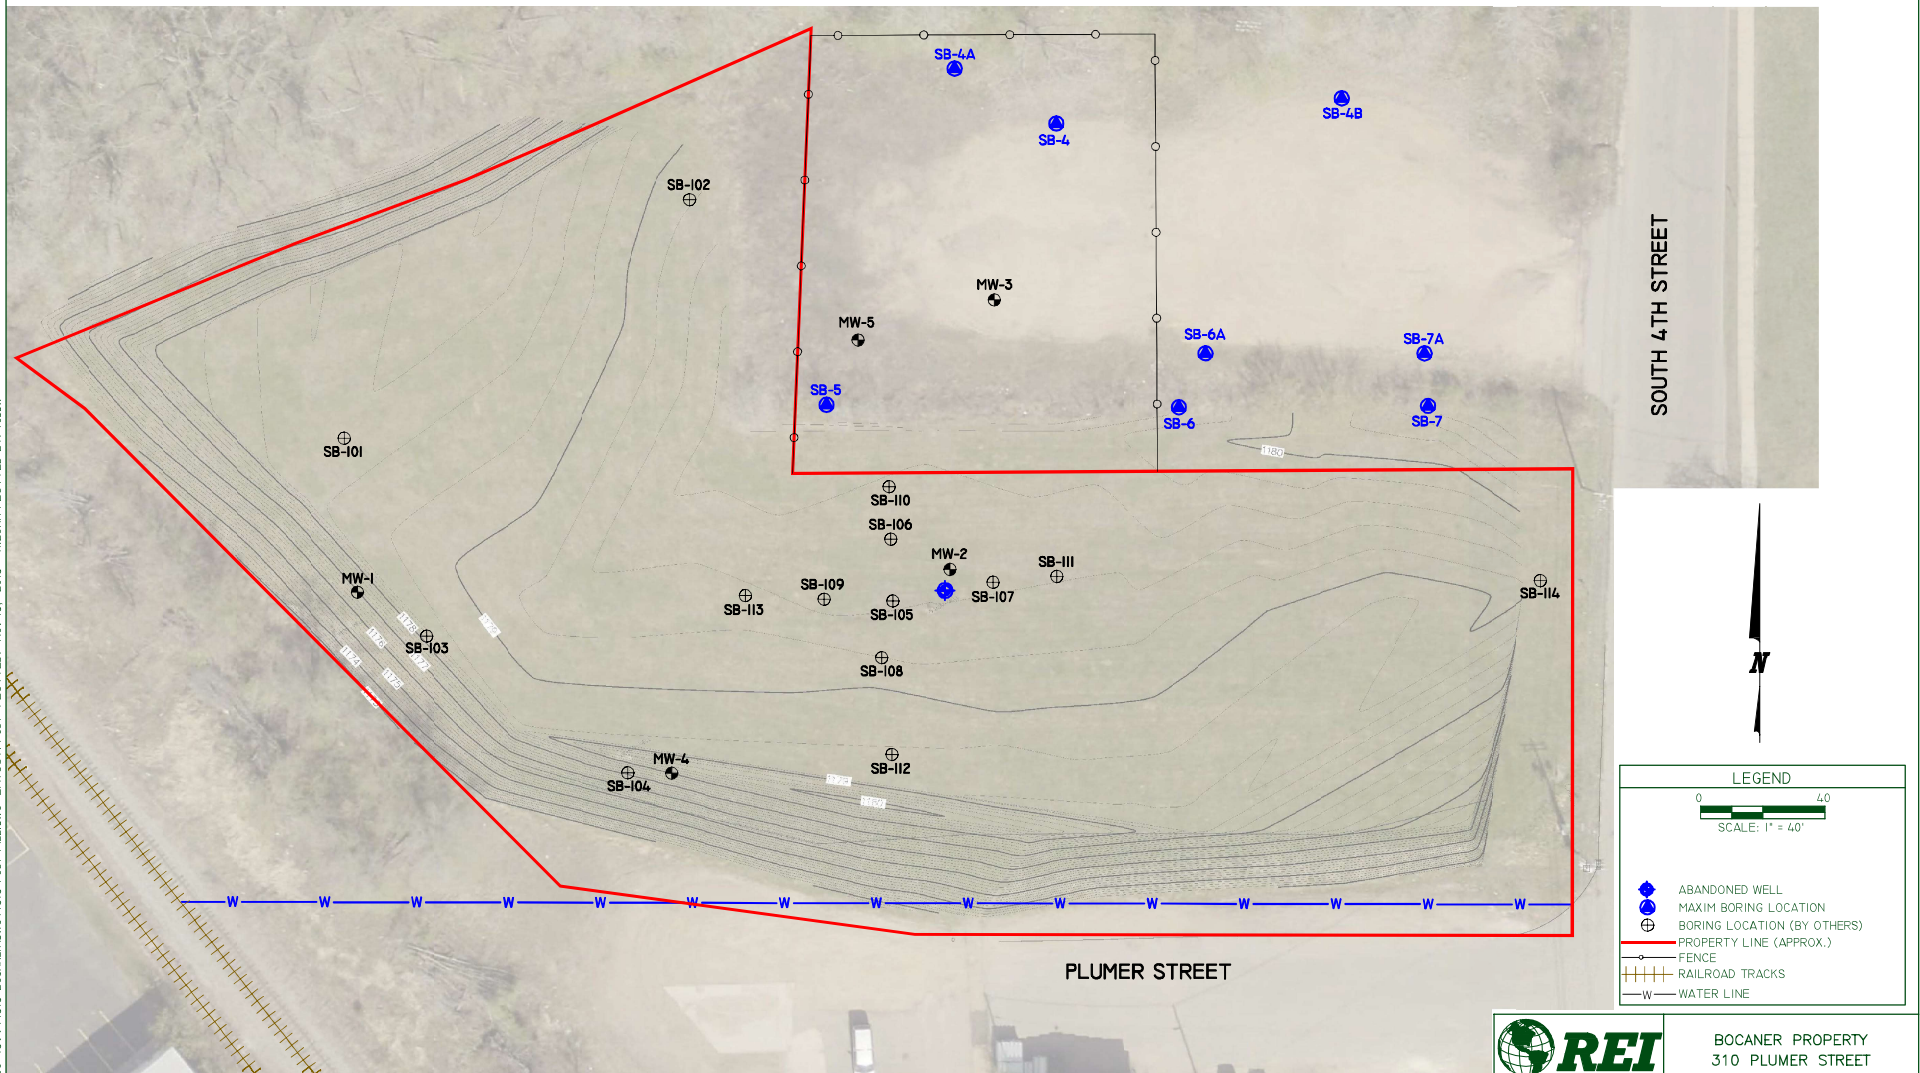
Figure 4. Sample Location Map (Reference 4)

The site was then subsequently capped with clean material.

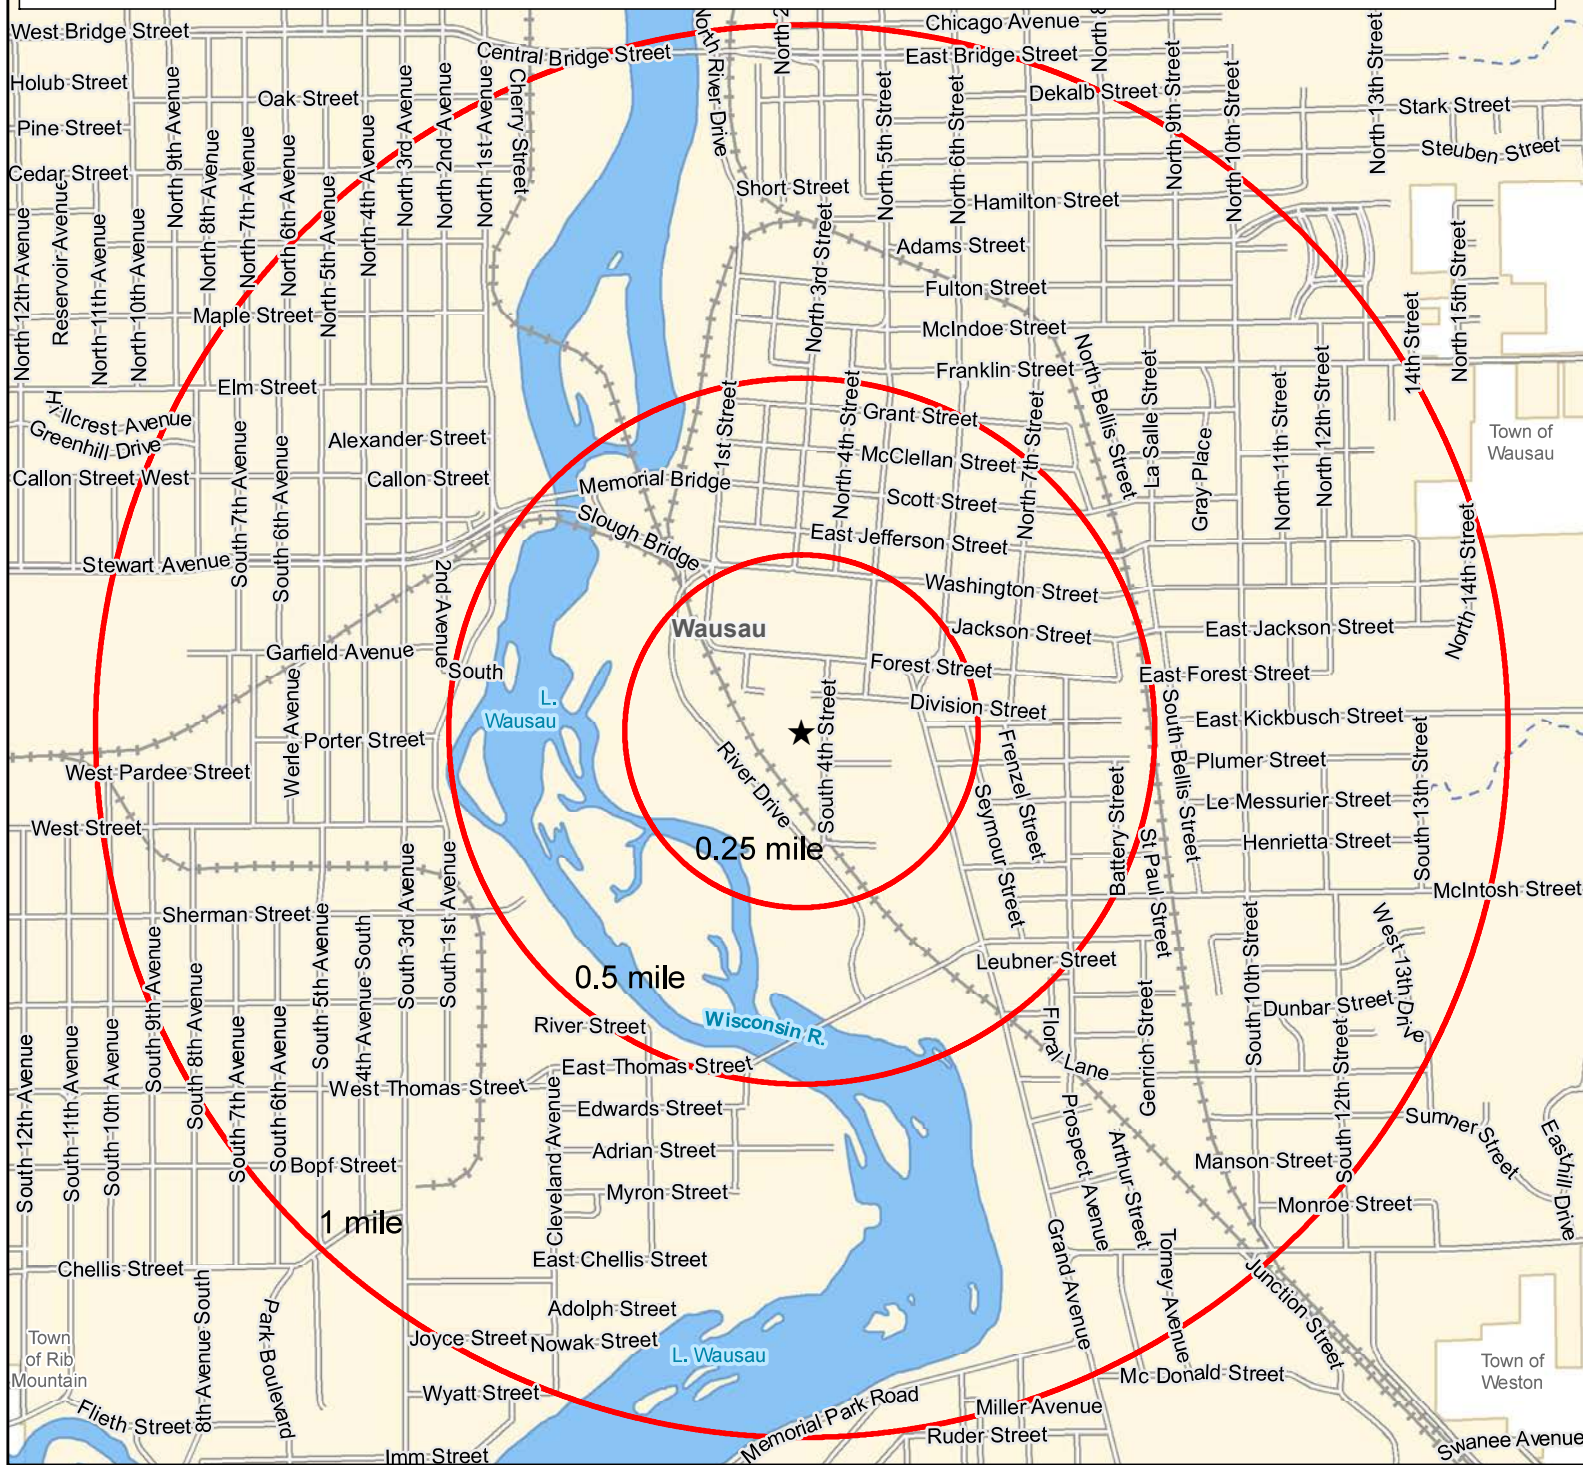
# Figure 6. Undeveloped Rosemurgy Property – 1 Mile Radius

| Distance | 2020 Population | 2020 Households |
| 0 - 0.25 mi | 470 | 191 |

The population within the four-mile radius of the Site is 50,329 people, with 11,912 people within the one-mile radius. A summary of the estimated 2020 census population data ([Reference 22](#)) is shown below. Associated maps are attached as [Figures 6 and 7](#).

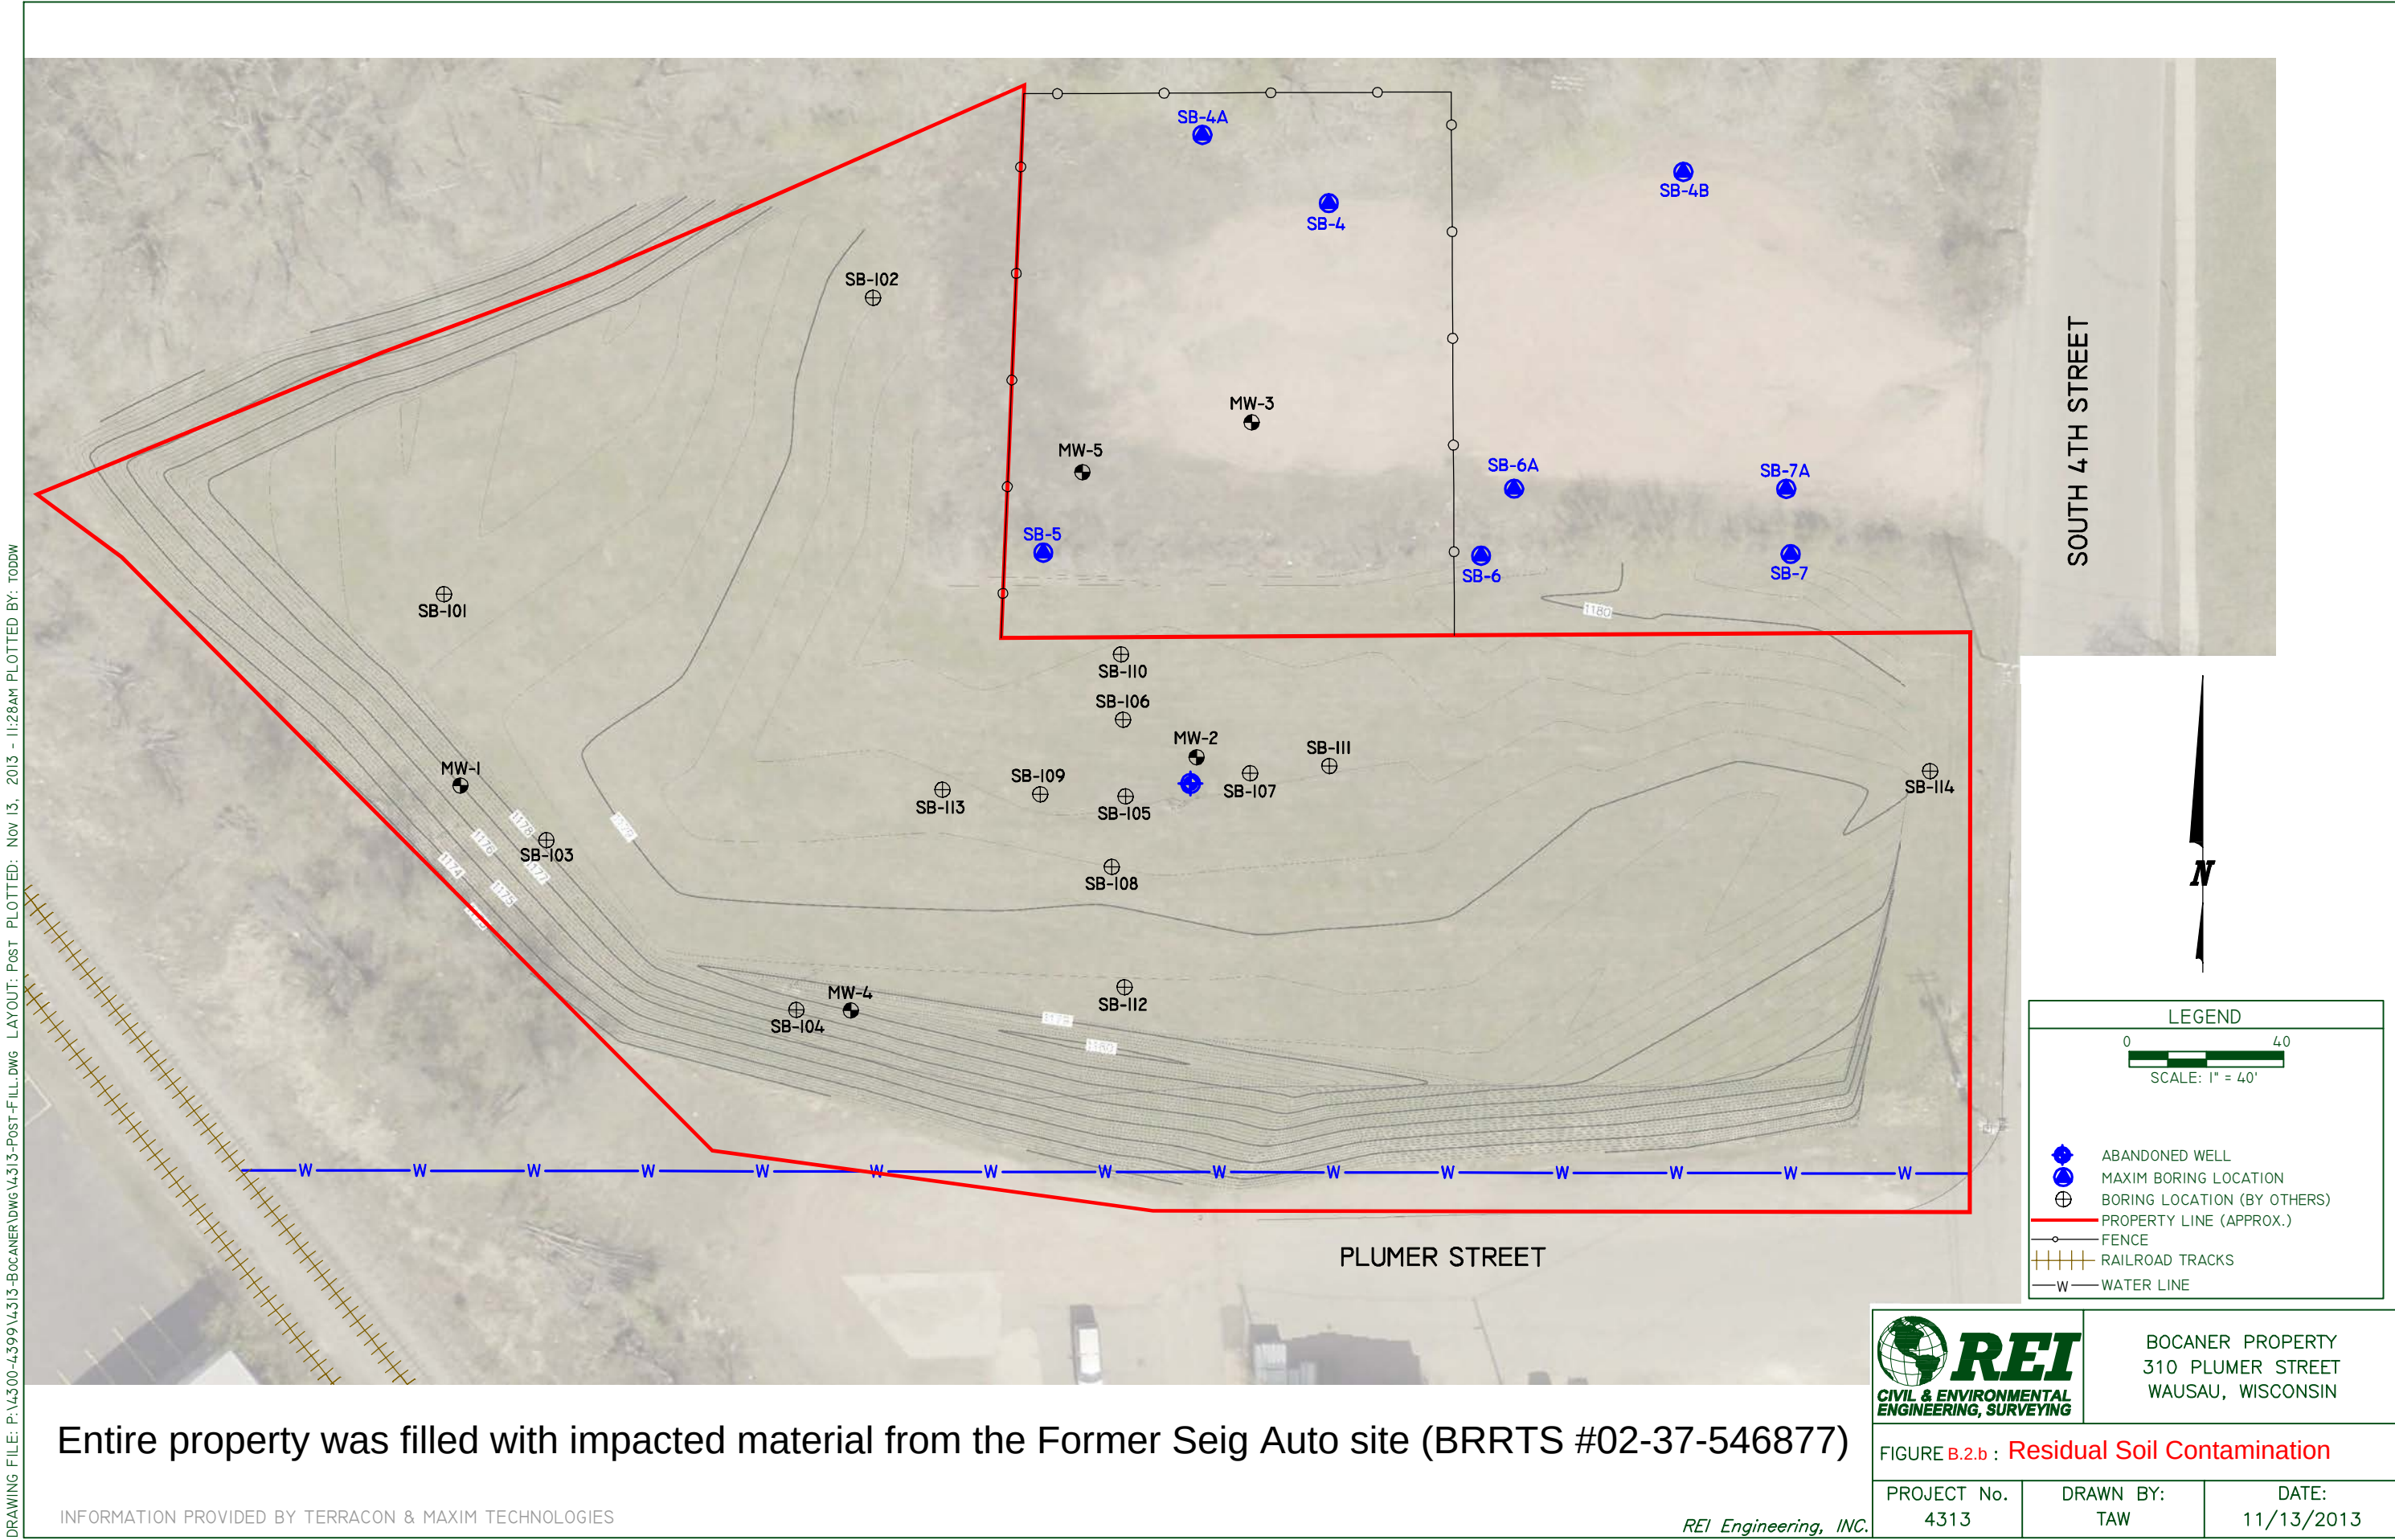
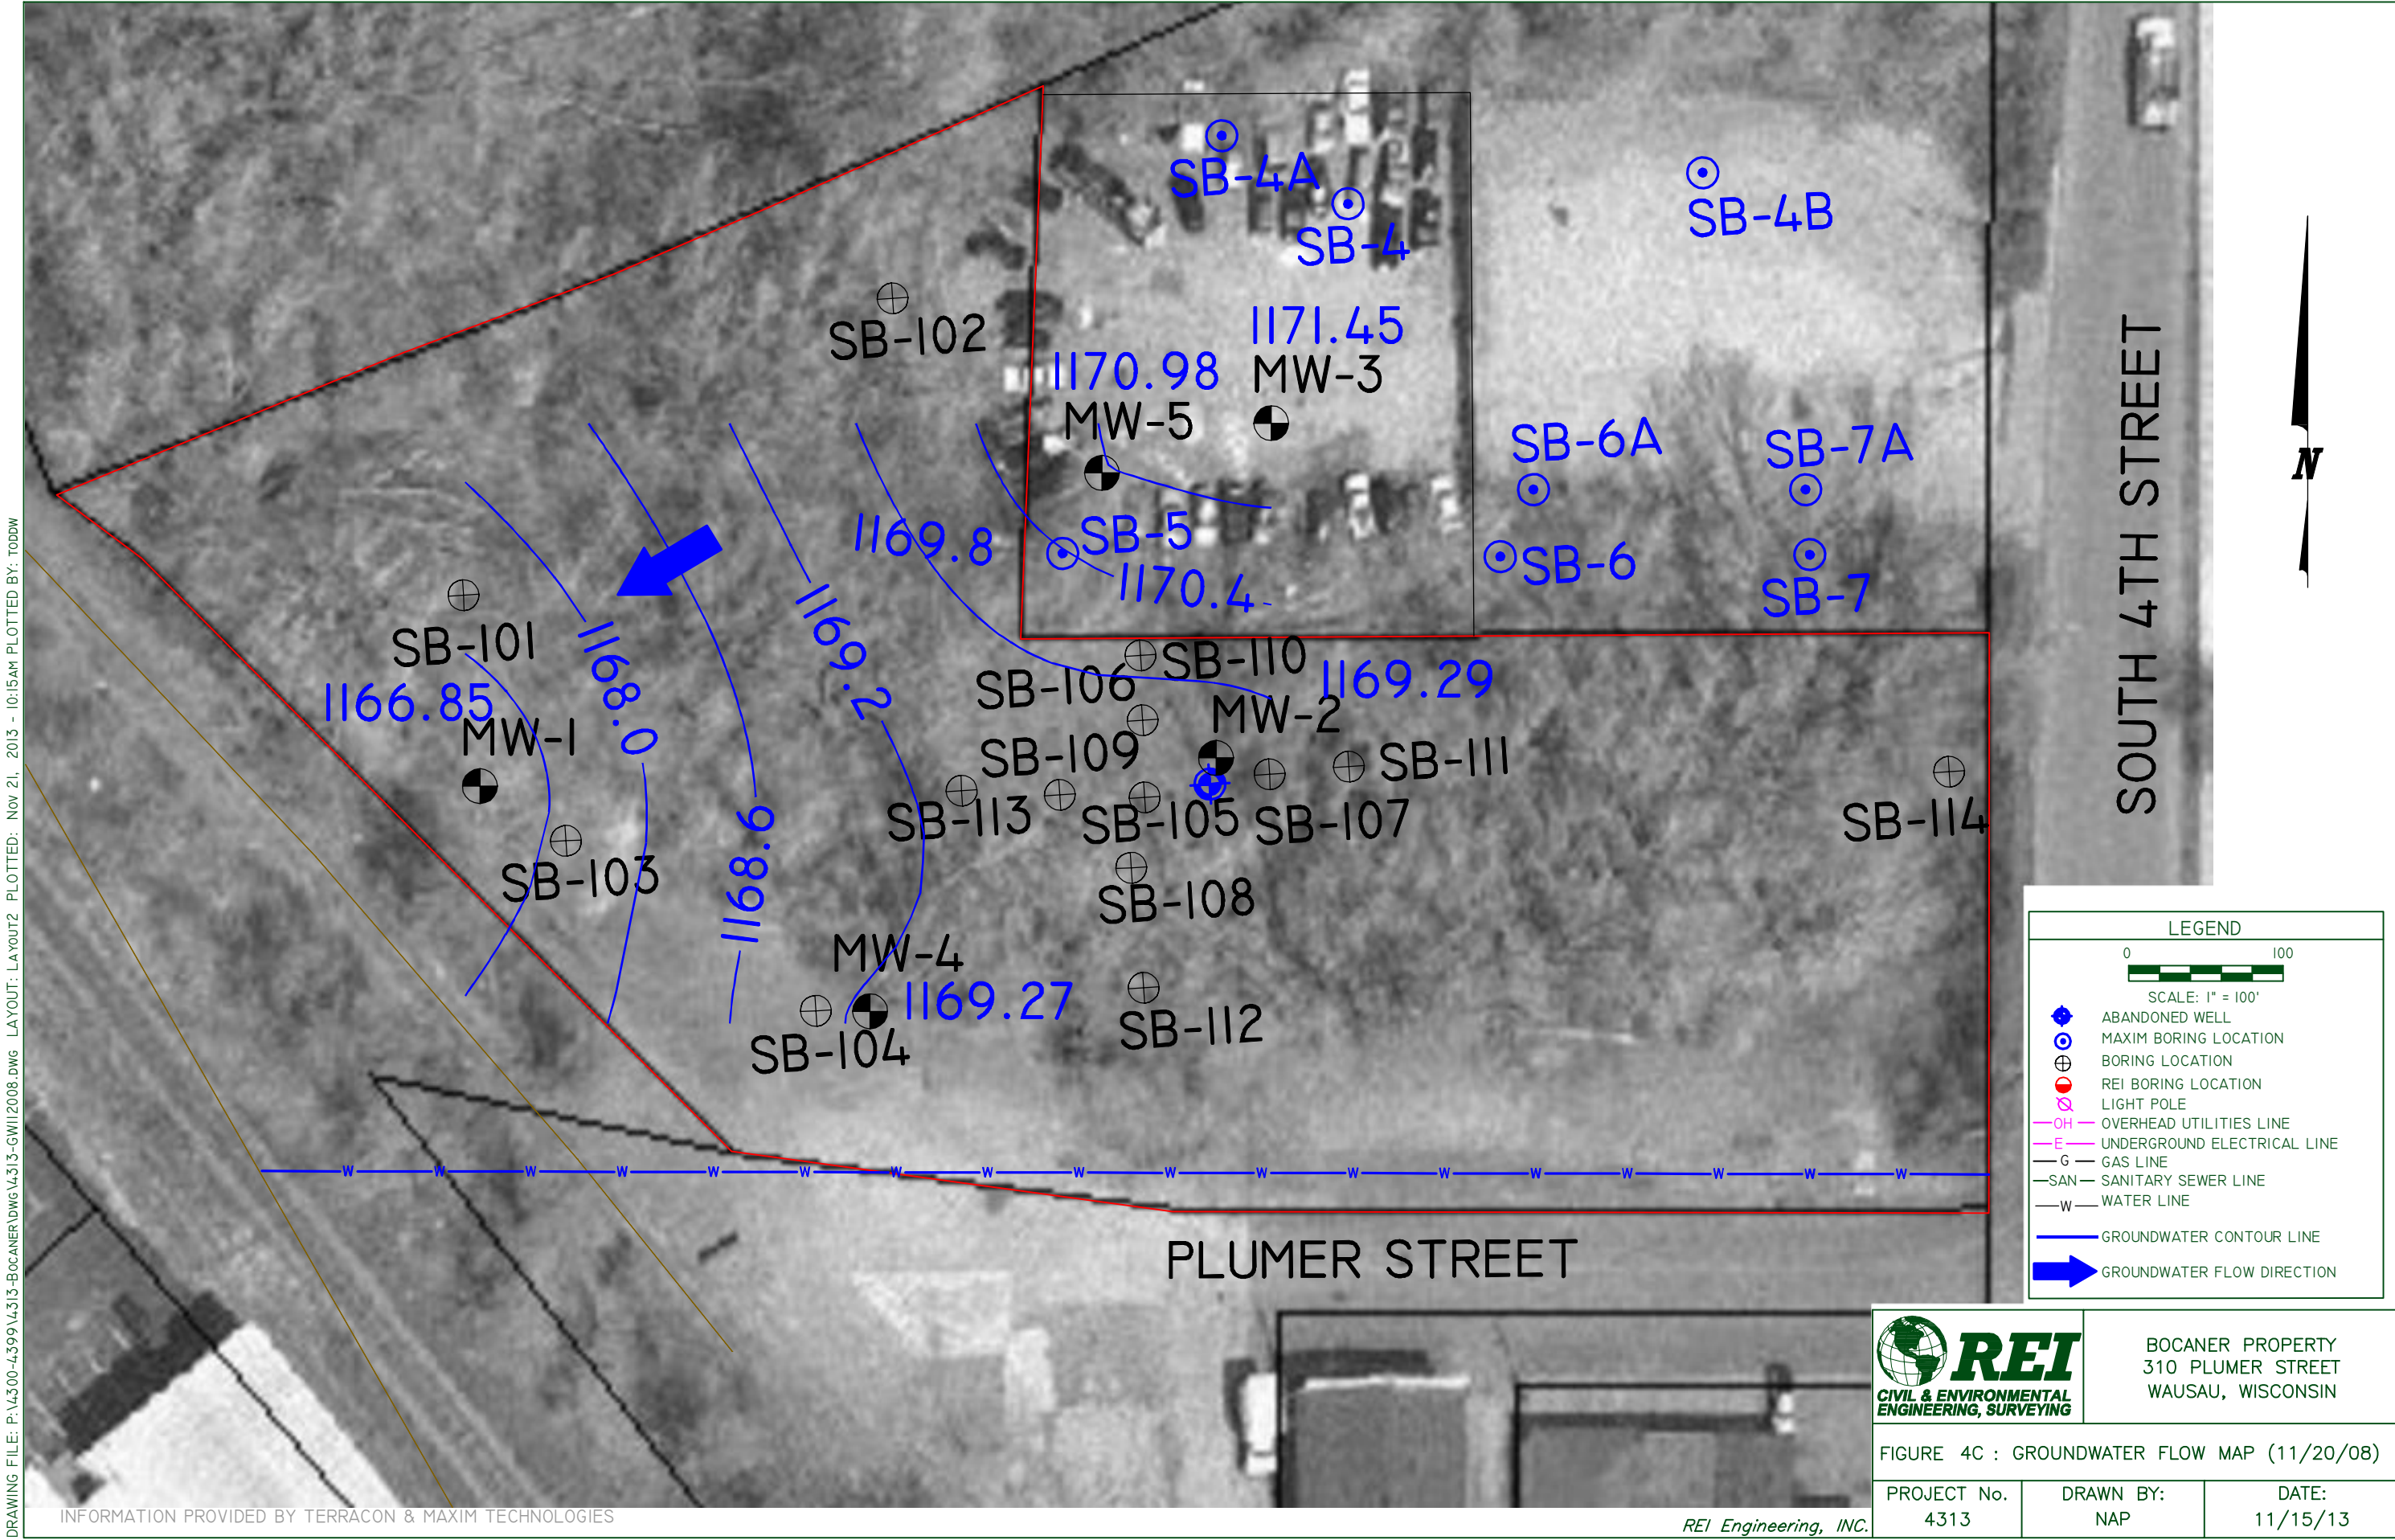
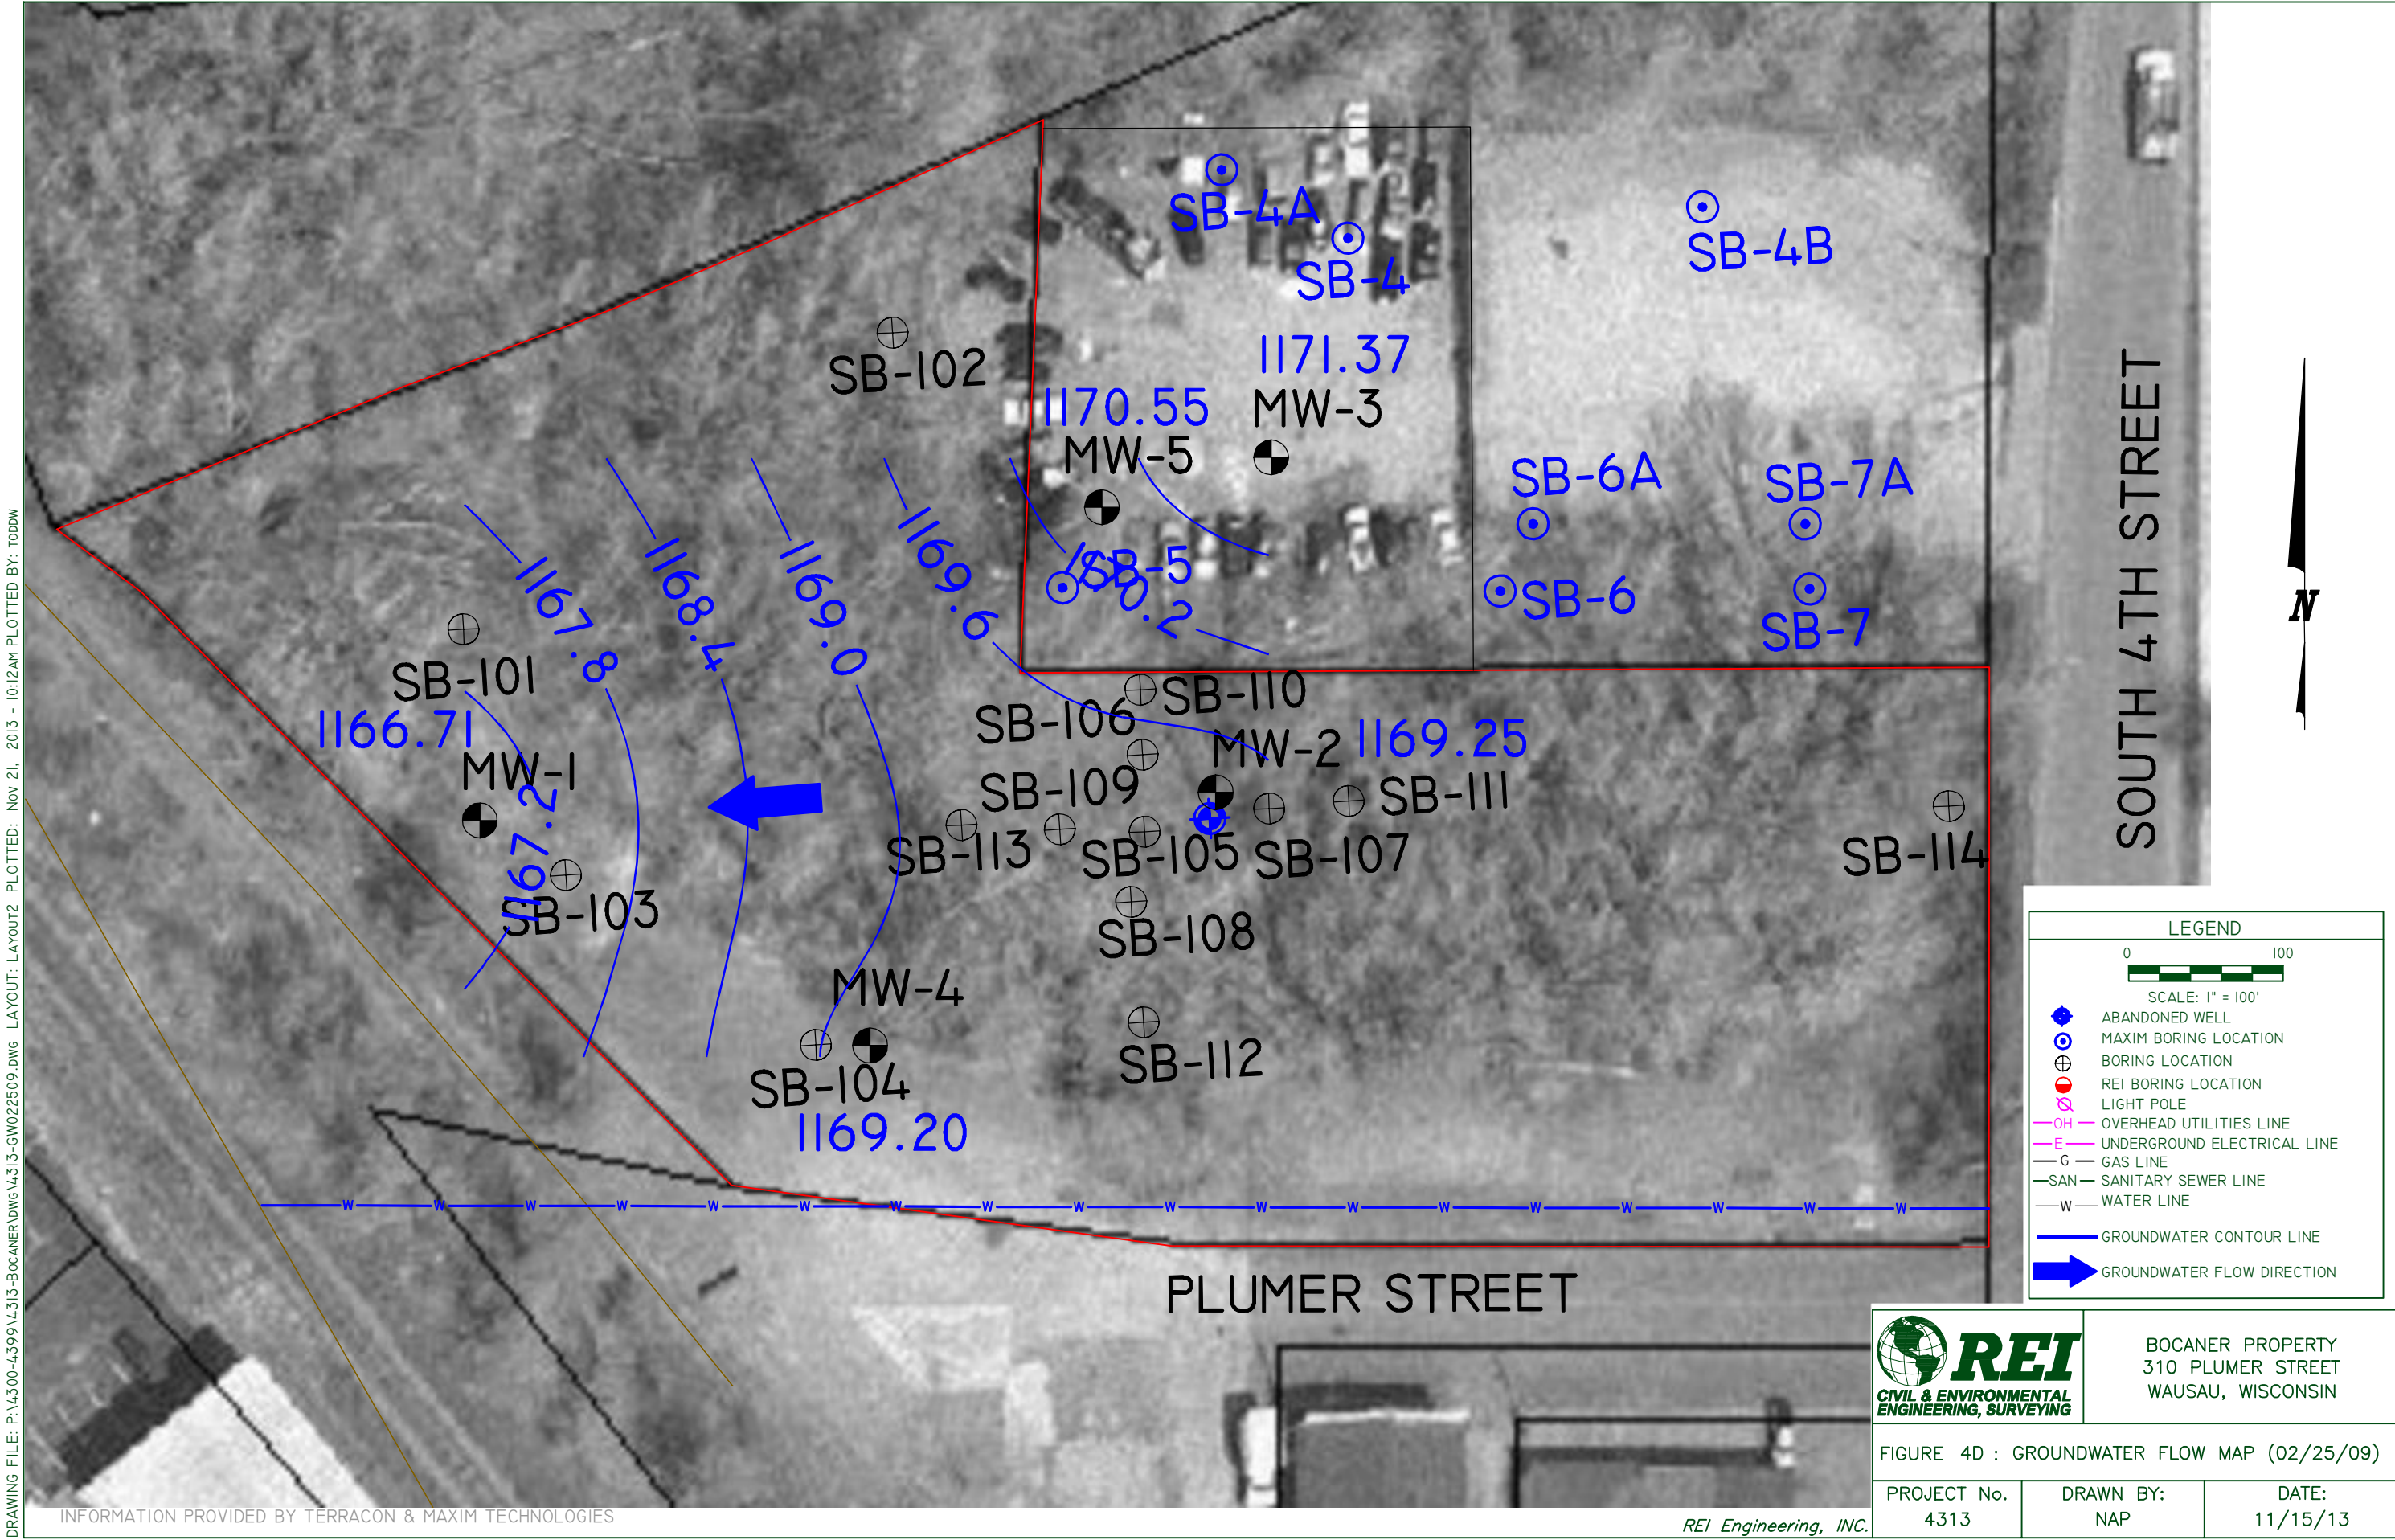
Soil contamination remains across the entirety of the site as indicated on the attached map, "Figure B.2.b, Residual Soil Contamination, 11/13/2013". If soil in the specific locations described above is excavated in the future, the property owner at the time of excavation must sample and analyze the excavated soil to determine if contamination remains. If sampling confirms that contamination is present, the property owner at the time of excavation will need to determine whether the material is considered solid or hazardous waste and ensure that any storage, treatment or disposal is in compliance with applicable standards and rules. Contaminated soil may be managed in accordance with ch. NR 718, Wis. Adm. Code, with prior DNR approval.

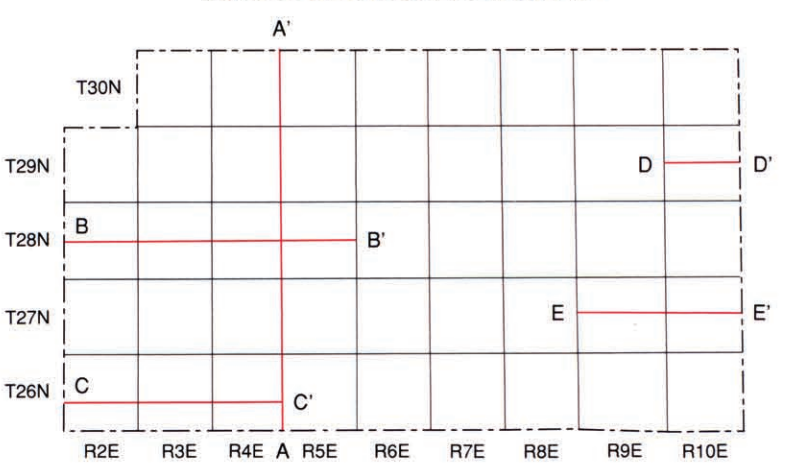
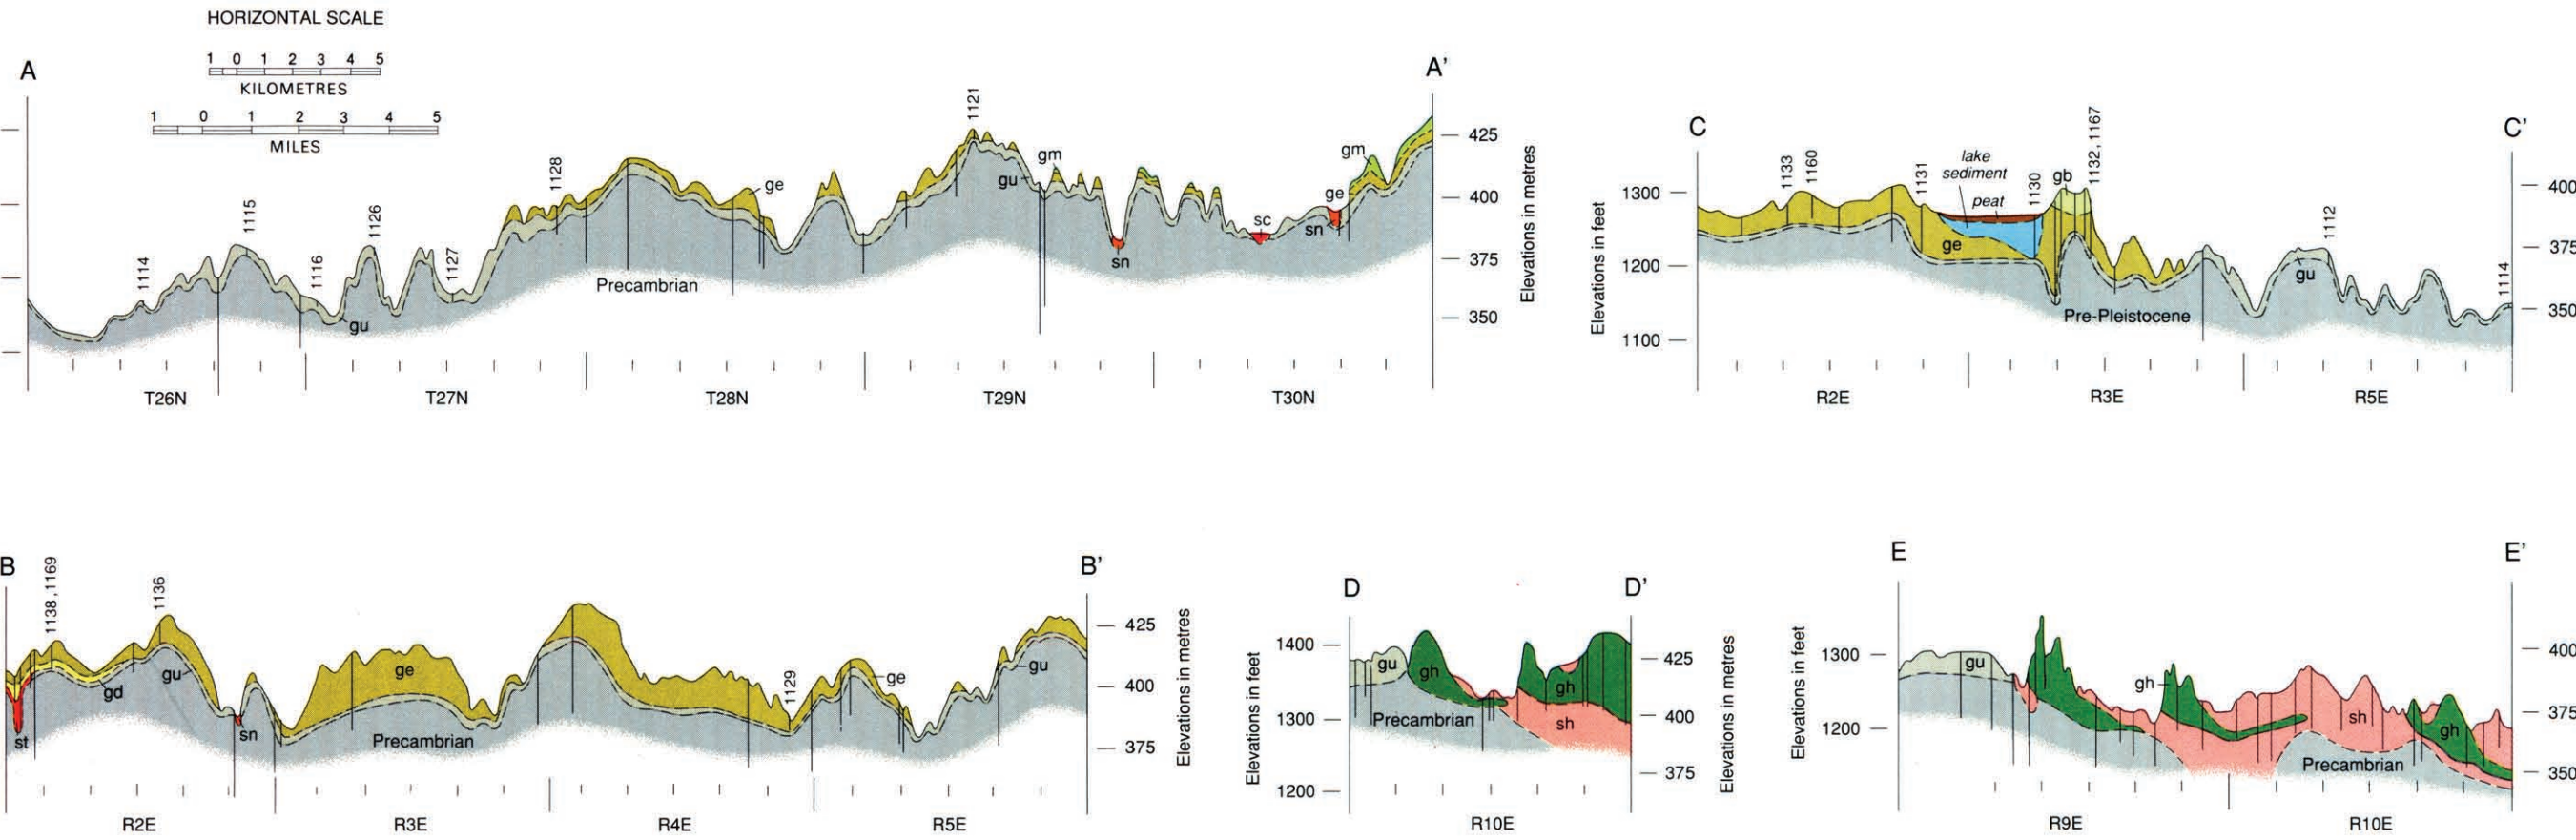
#### CROSS-SECTION LOCATIONS

Sections A-A' through E-E' show the generalized vertical relationships between geologic units. They are based on the surface distribution of materials, logs of holes drilled as a part of this study, and logs of other drillholes that are on file at the Wisconsin Geological and Natural History Survey in Madison. The unit designations are the same as those used on the map with the following additions: unit **gd**, till of the Medford Member of the Marathon Formation, a unit that does not occur at the surface in Marathon County, and unit **st**, undifferentiated meltwater and nonglacial stream sediment of various ages. The contacts between units are judged to be within 3 m of the true contact in most places. The vertical exaggeration is about 84 times.

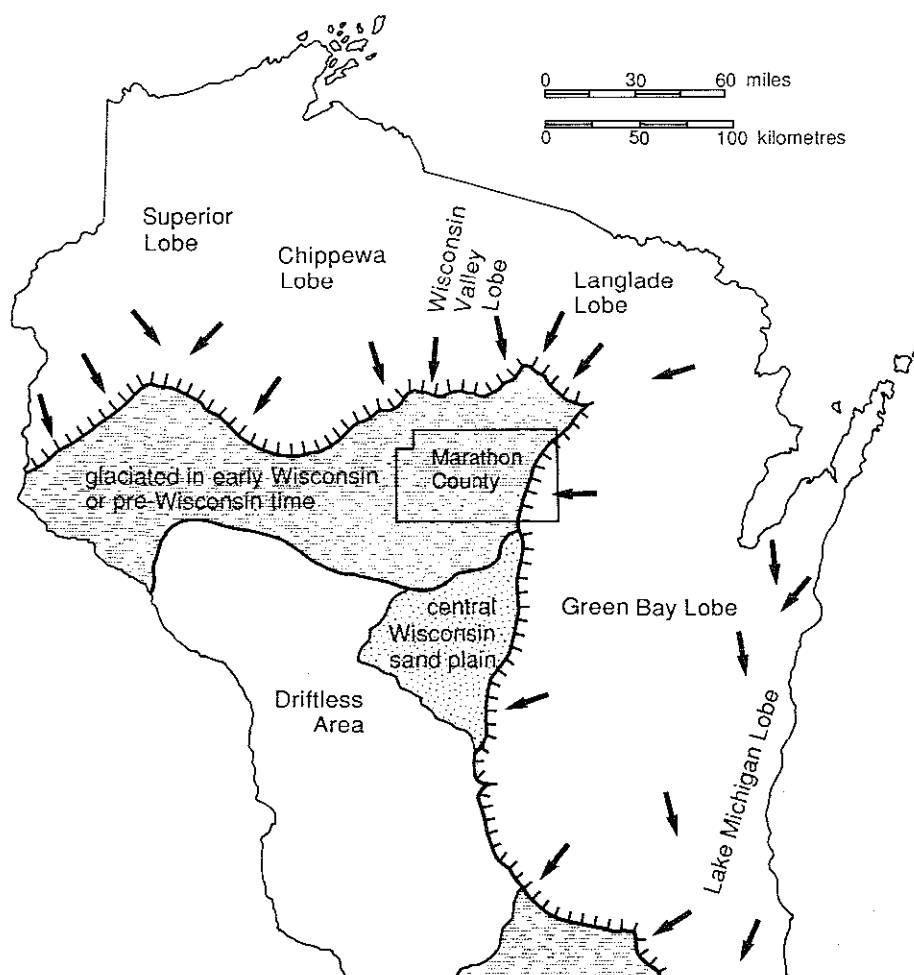
**Figure 1.** Location of Marathon County and the extent of glaciation in Wisconsin. The arrows show the direction of late Wisconsin ice flow.

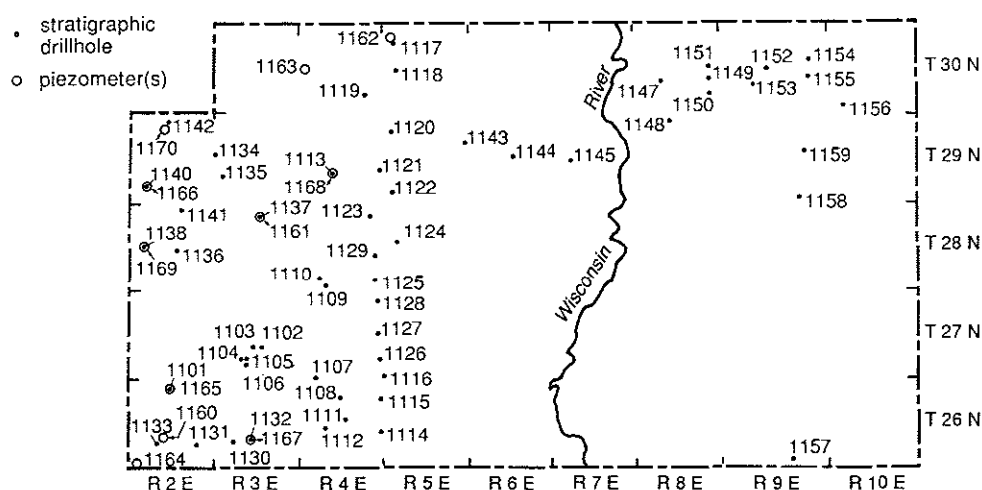
Figure 2. Location of holes drilled to sample sediment and install piezometers.

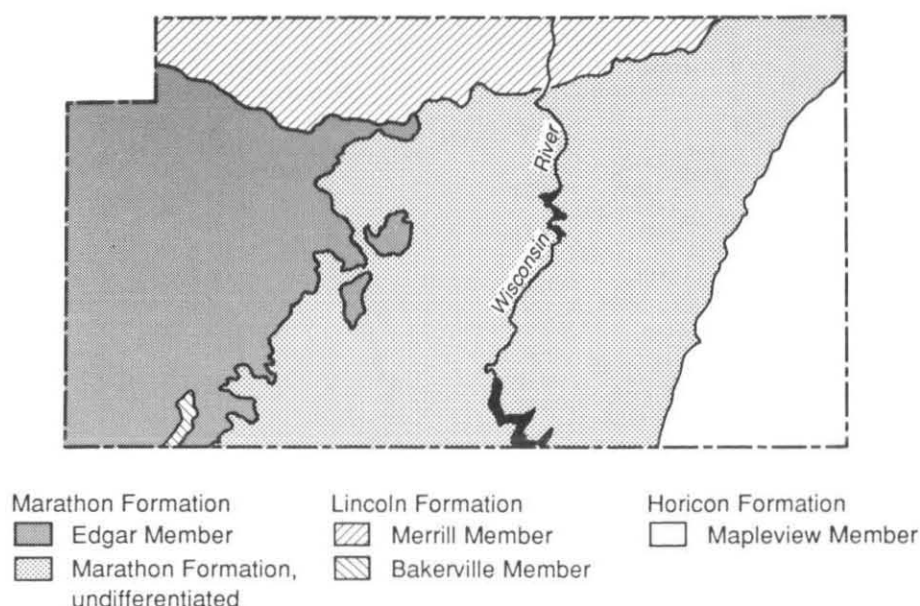
**Figure 3.** General distribution of lithostratigraphic units in Marathon County.

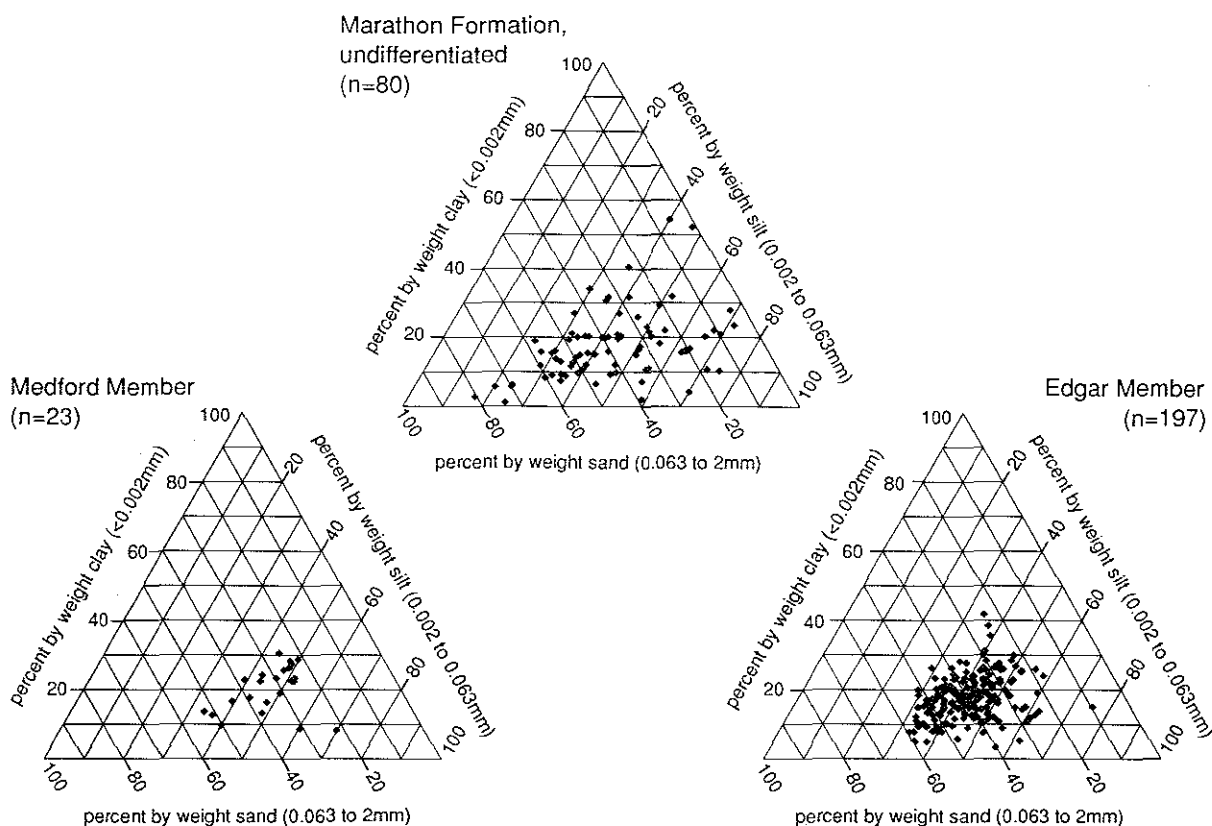
**Figure 4.** Grain-size distribution of the finer-than-2-mm fraction of samples from the Marathon Formation. The plots showing data for the Edgar and Medford Members show only results from samples of till. The plot for the undifferentiated Marathon Formation includes samples that may be from till, residuum, or hillslope sediment.

Our eighty samples of undifferentiated material from the Marathon Formation had an average ratio of sand:silt:clay of 39:44:17 for the finer-than-2-mm fraction (fig. 4; table 1). These results are similar to those given by Mode (1976) from 15 Marathon County samples of the Wausau Member of the Marathon Formation; he reported a ratio of sand:silt:clay of 43:34:23. Mickelson (1986) reported a sand:silt:clay ratio of 52:34:14 for till of the Wausau Member in adjacent Langlade County. Our results from the samples of Marathon Formation, undifferentiated, show variability in grain-size distribution (figs. 4 and 5),

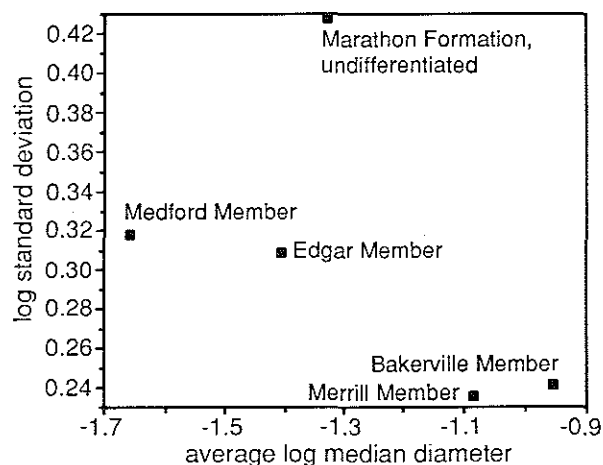
**Figure 5.** Grain-size variation of the till units deposited prior to late Wisconsin time. The median diameter of a sample is used to characterize grain-size distribution. The diagram shows a plot of the  $\log_{10}$  average median diameter of each unit against the  $\log_{10}$  standard deviation around that diameter.
