## OFFICIAL NOTICE AND AGENDA

Meeting of the: **PARKS AND RECREATION COMMITTEE OF THE CITY OF WAUSAU**  
Date/Time: **Monday, April 3, 2023 at 4:30pm**  
Location: **1703 Cherry Street for EAB review then to City Hall (407 Grant St, Wausau WI 54403) - Council Chambers**  
Members: **Dawn Herbst, Carol Lukens, Tom Kilian, Lou Larson, Sarah Watson**

## March Update

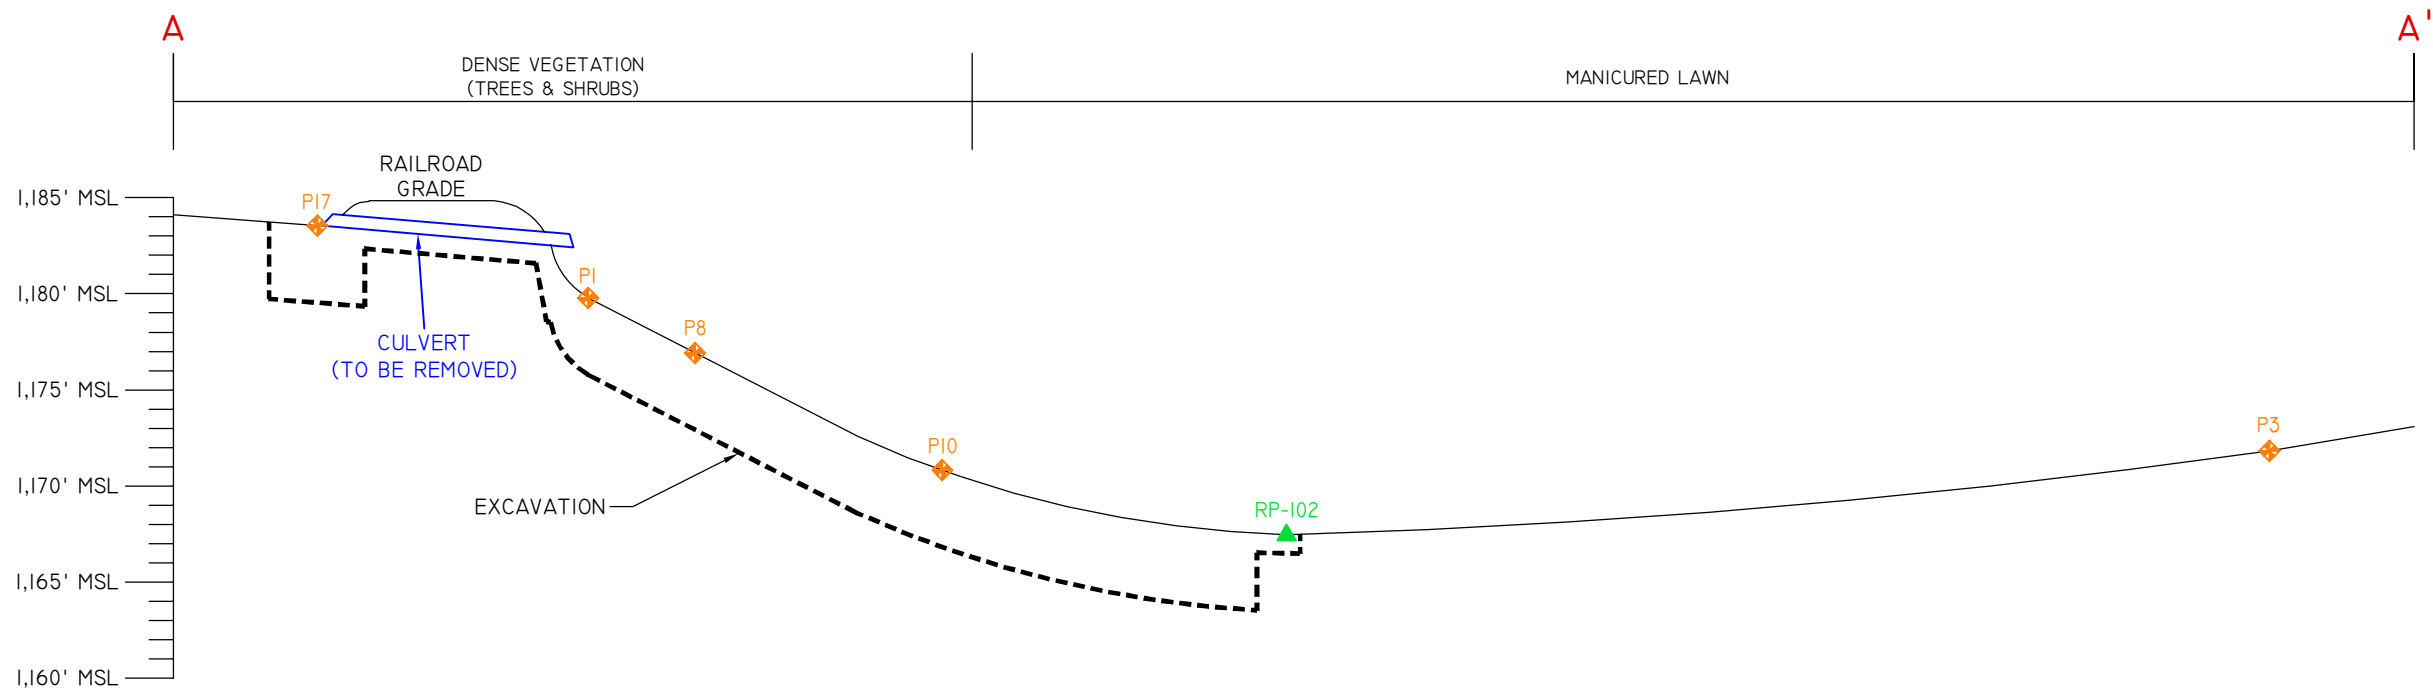
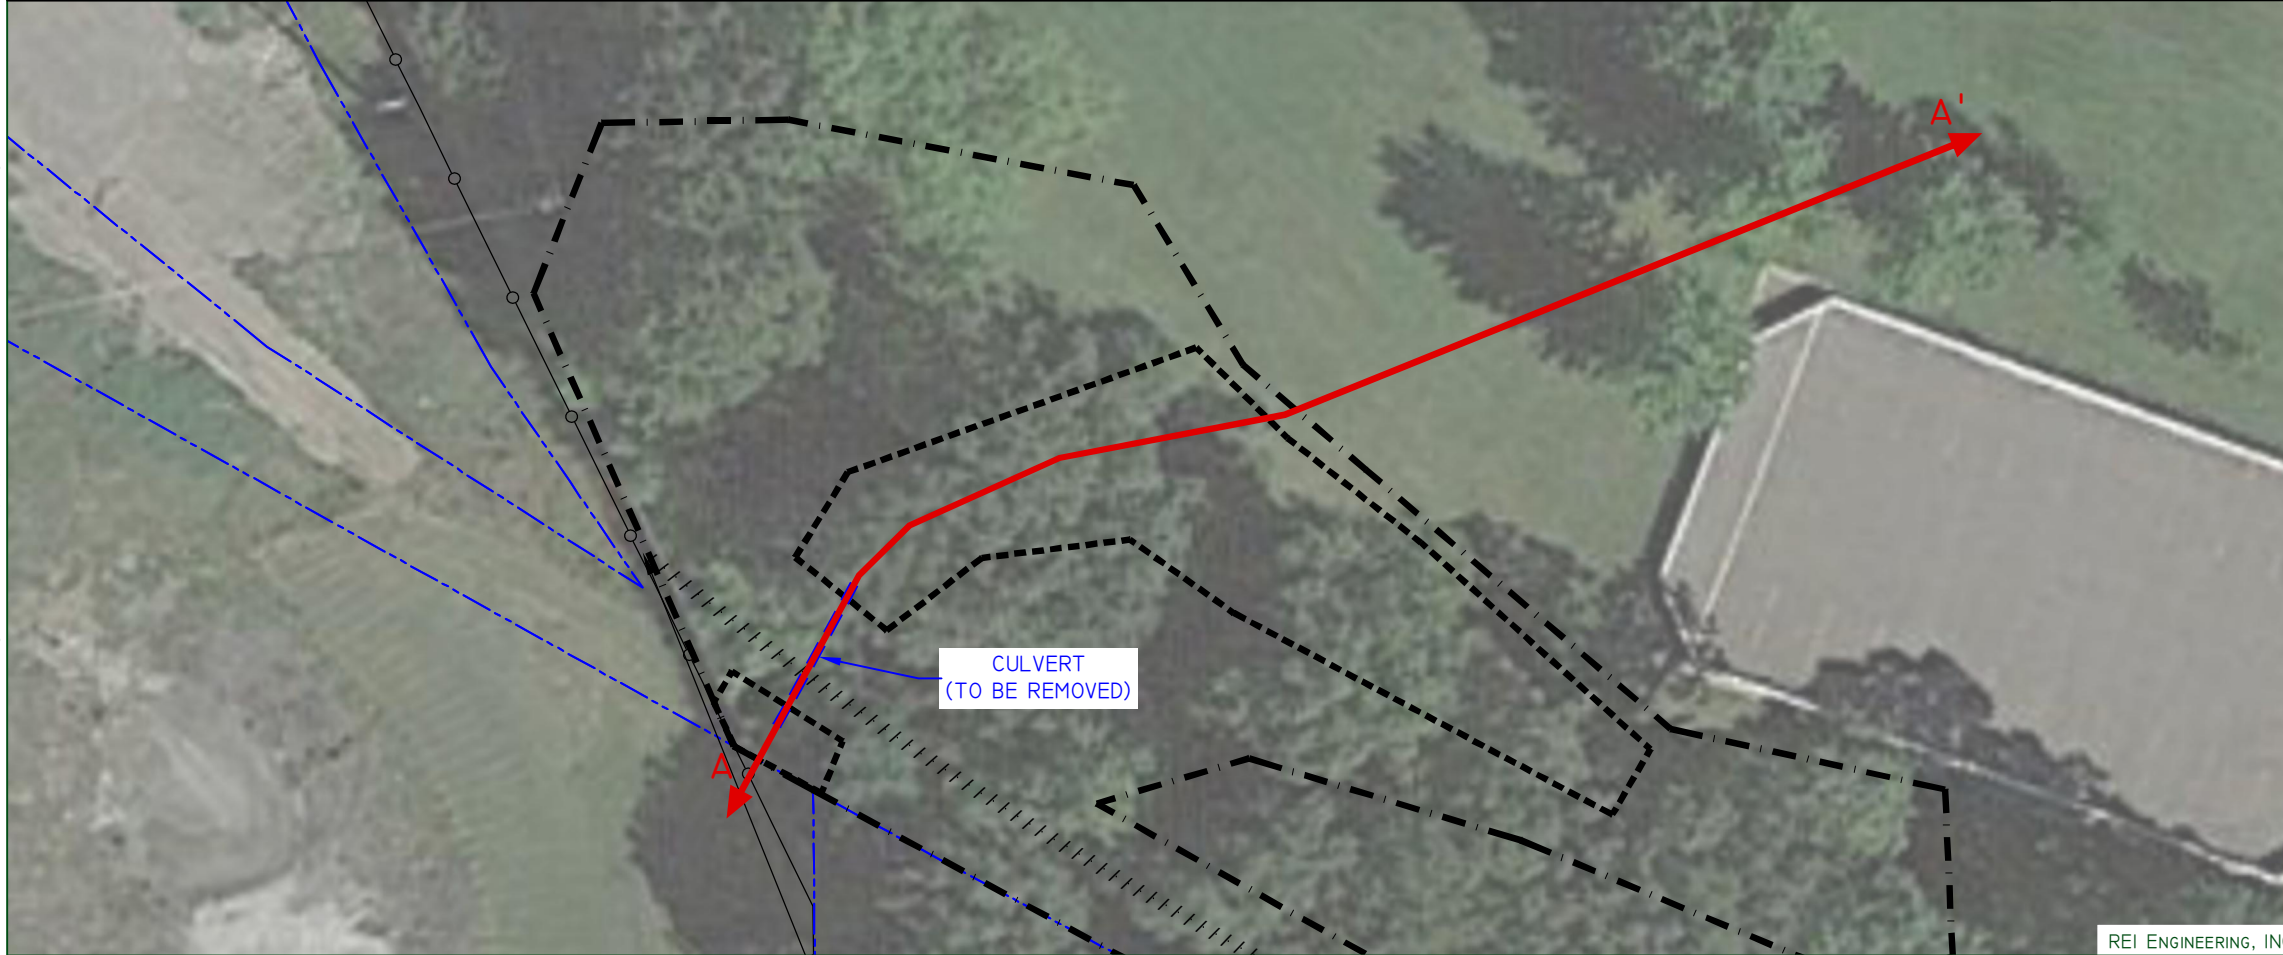
FIGURE 5 : ELEVATION PROFILE A-A'

HORIZONTAL SCALE: 1"=20'  
VERTICAL SCALE: 1"=10'
