Meeting of the: **PARKS AND RECREATION COMMITTEE OF THE CITY OF WAUSAU**  
Date/Time: **Monday, October 4, 2021 at 4:30 pm**  
Location: **Riverside Park Shelter (100 Sherman St, Wausau WI 54401)**  
Members: **Tom Neal, Patrick Peckham, Tom Kilian, Lou Larson, Sarah Watson**

**DRAFT**  
**CITY OF WAUSAU – PARK AND RECREATION COMMITTEE MEETING MINUTES**

**BRRTS #02-37-584785**

**REI PROJECT #9073**

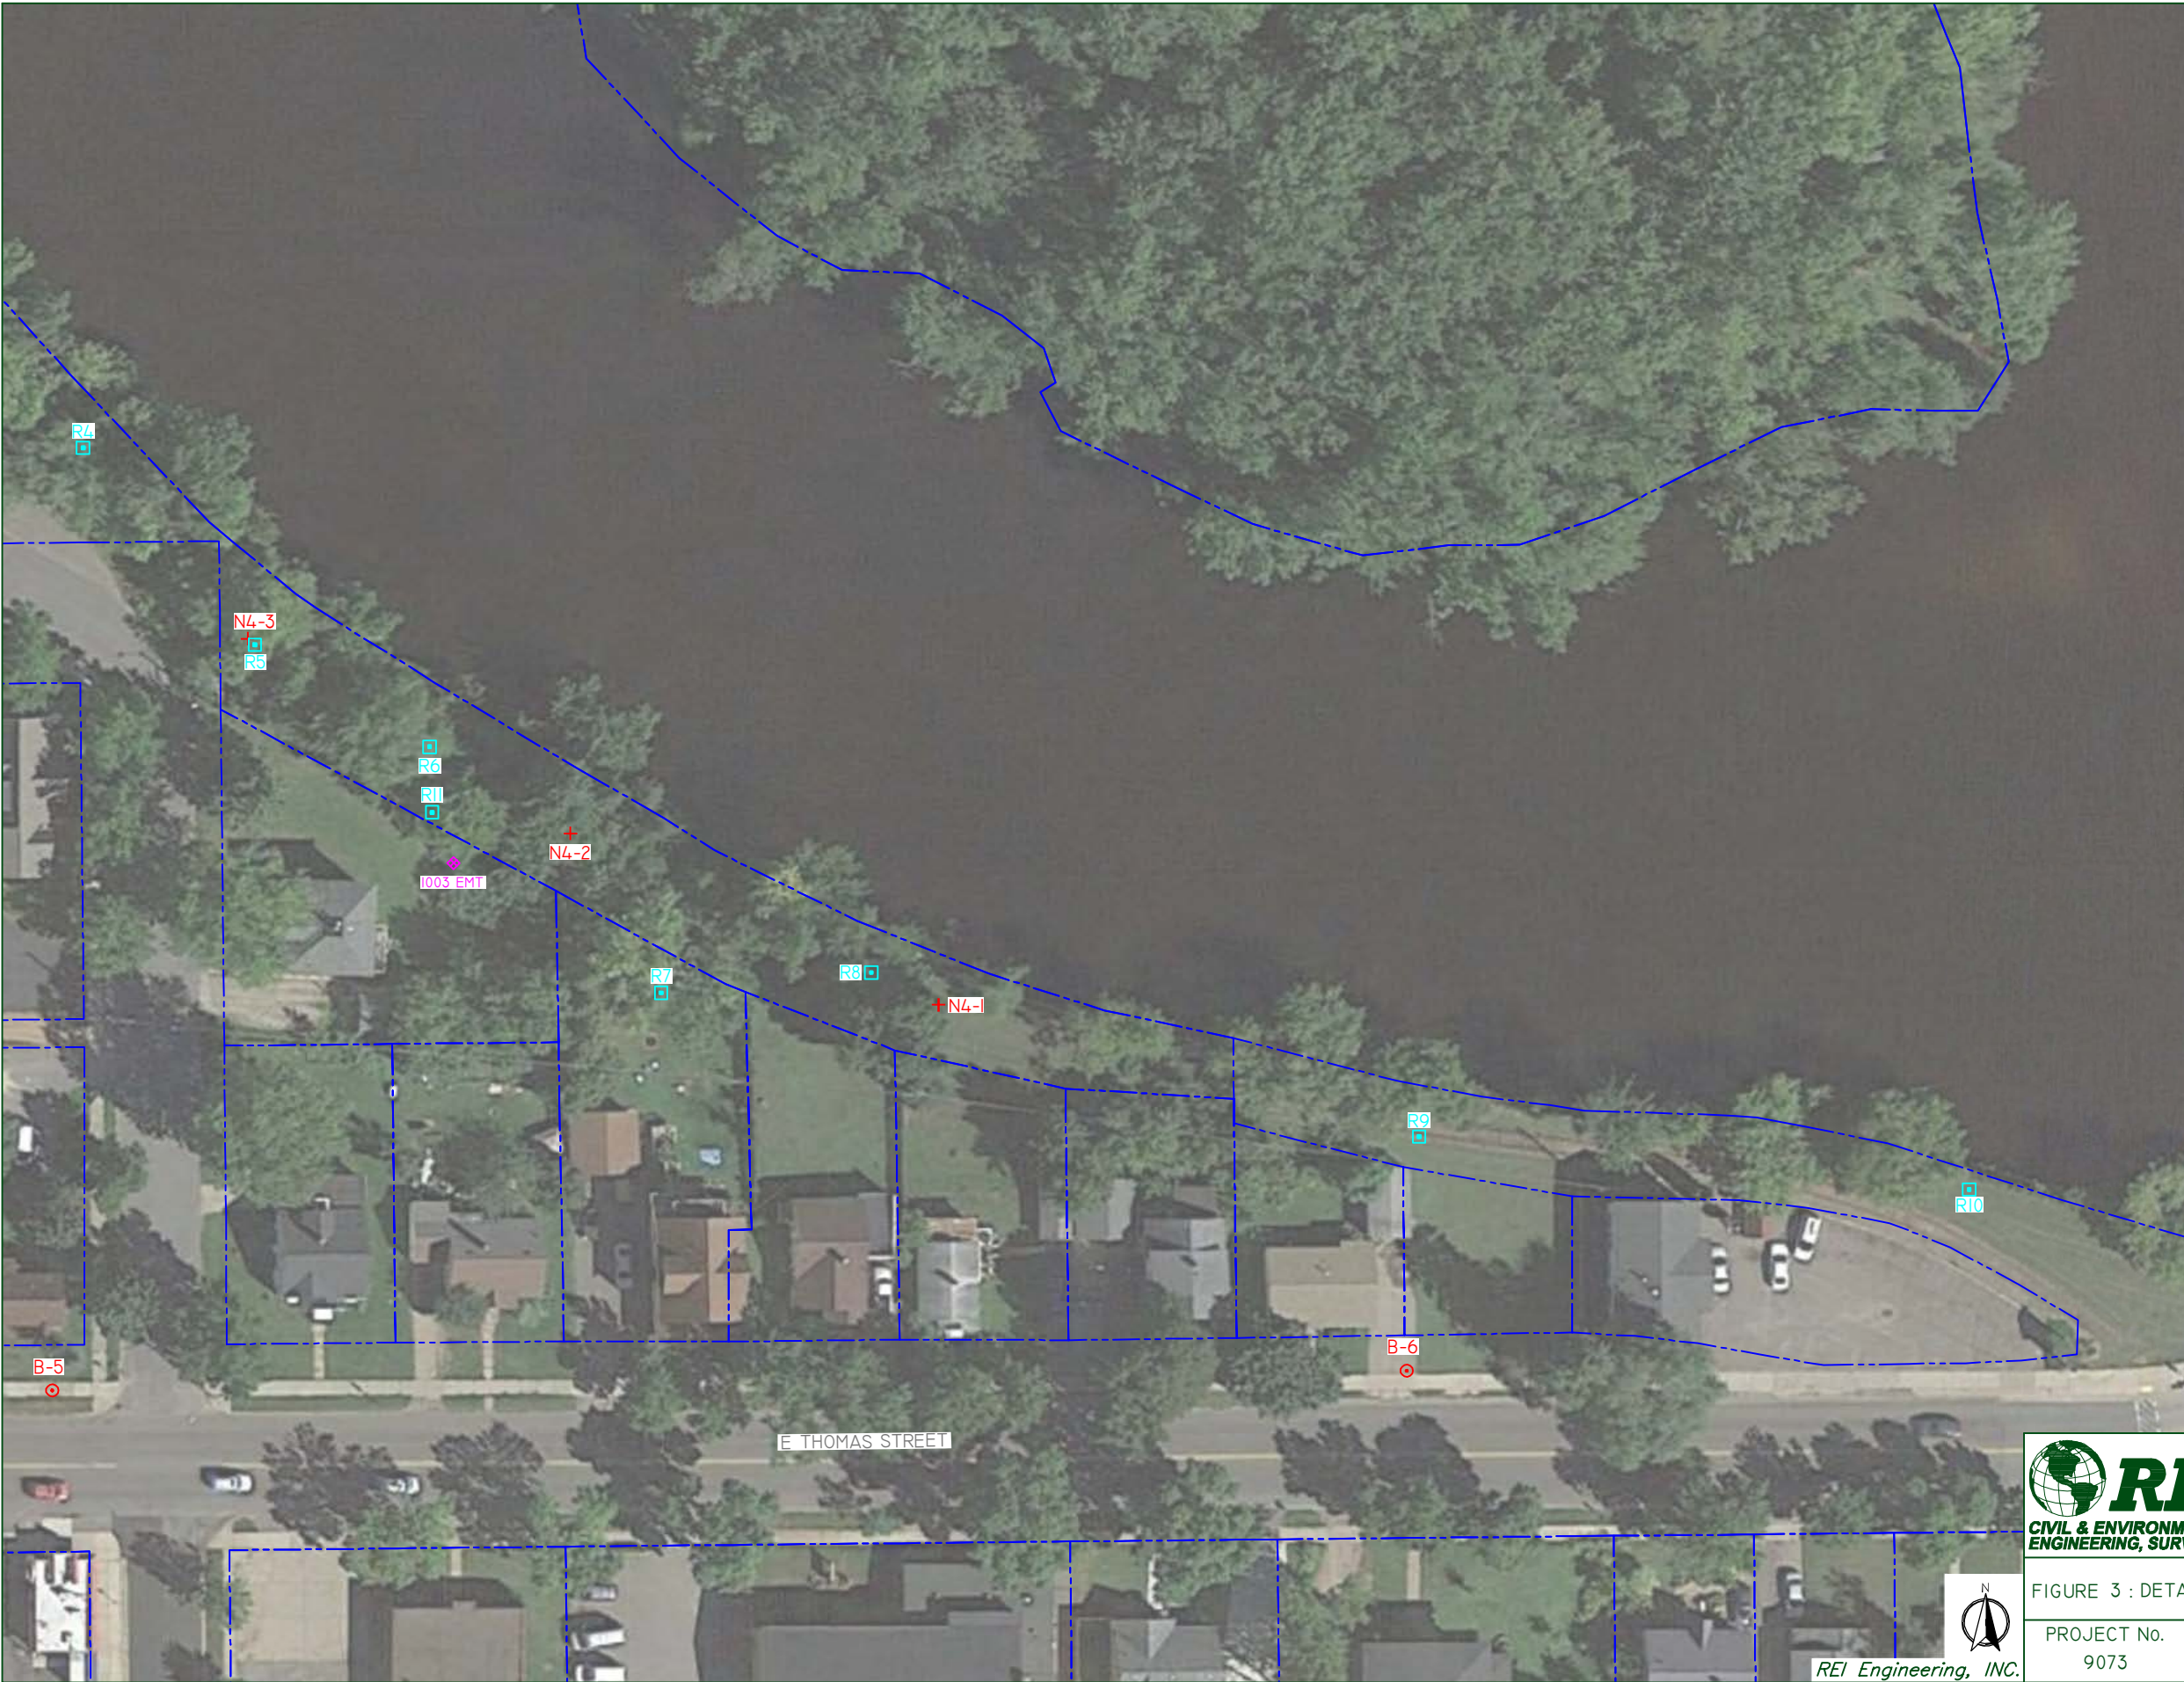
DRAWING FILE: P:\9000-9099\9073 - CITY OF WAUSAU RIVERSIDE RR CORRIDOR\dwgs\9073-DETAILED SITE.DWG LAYOUT: RR CloseUP PLOTTED: SEP 13, 2021 - 2:13PM PLOTTED BY: MATTM

| LEGEND | | |
|---|---|--|
| | SOIL SAMPLE - RR CORRIDOR<br>- REI ENGINEERING, INC | |

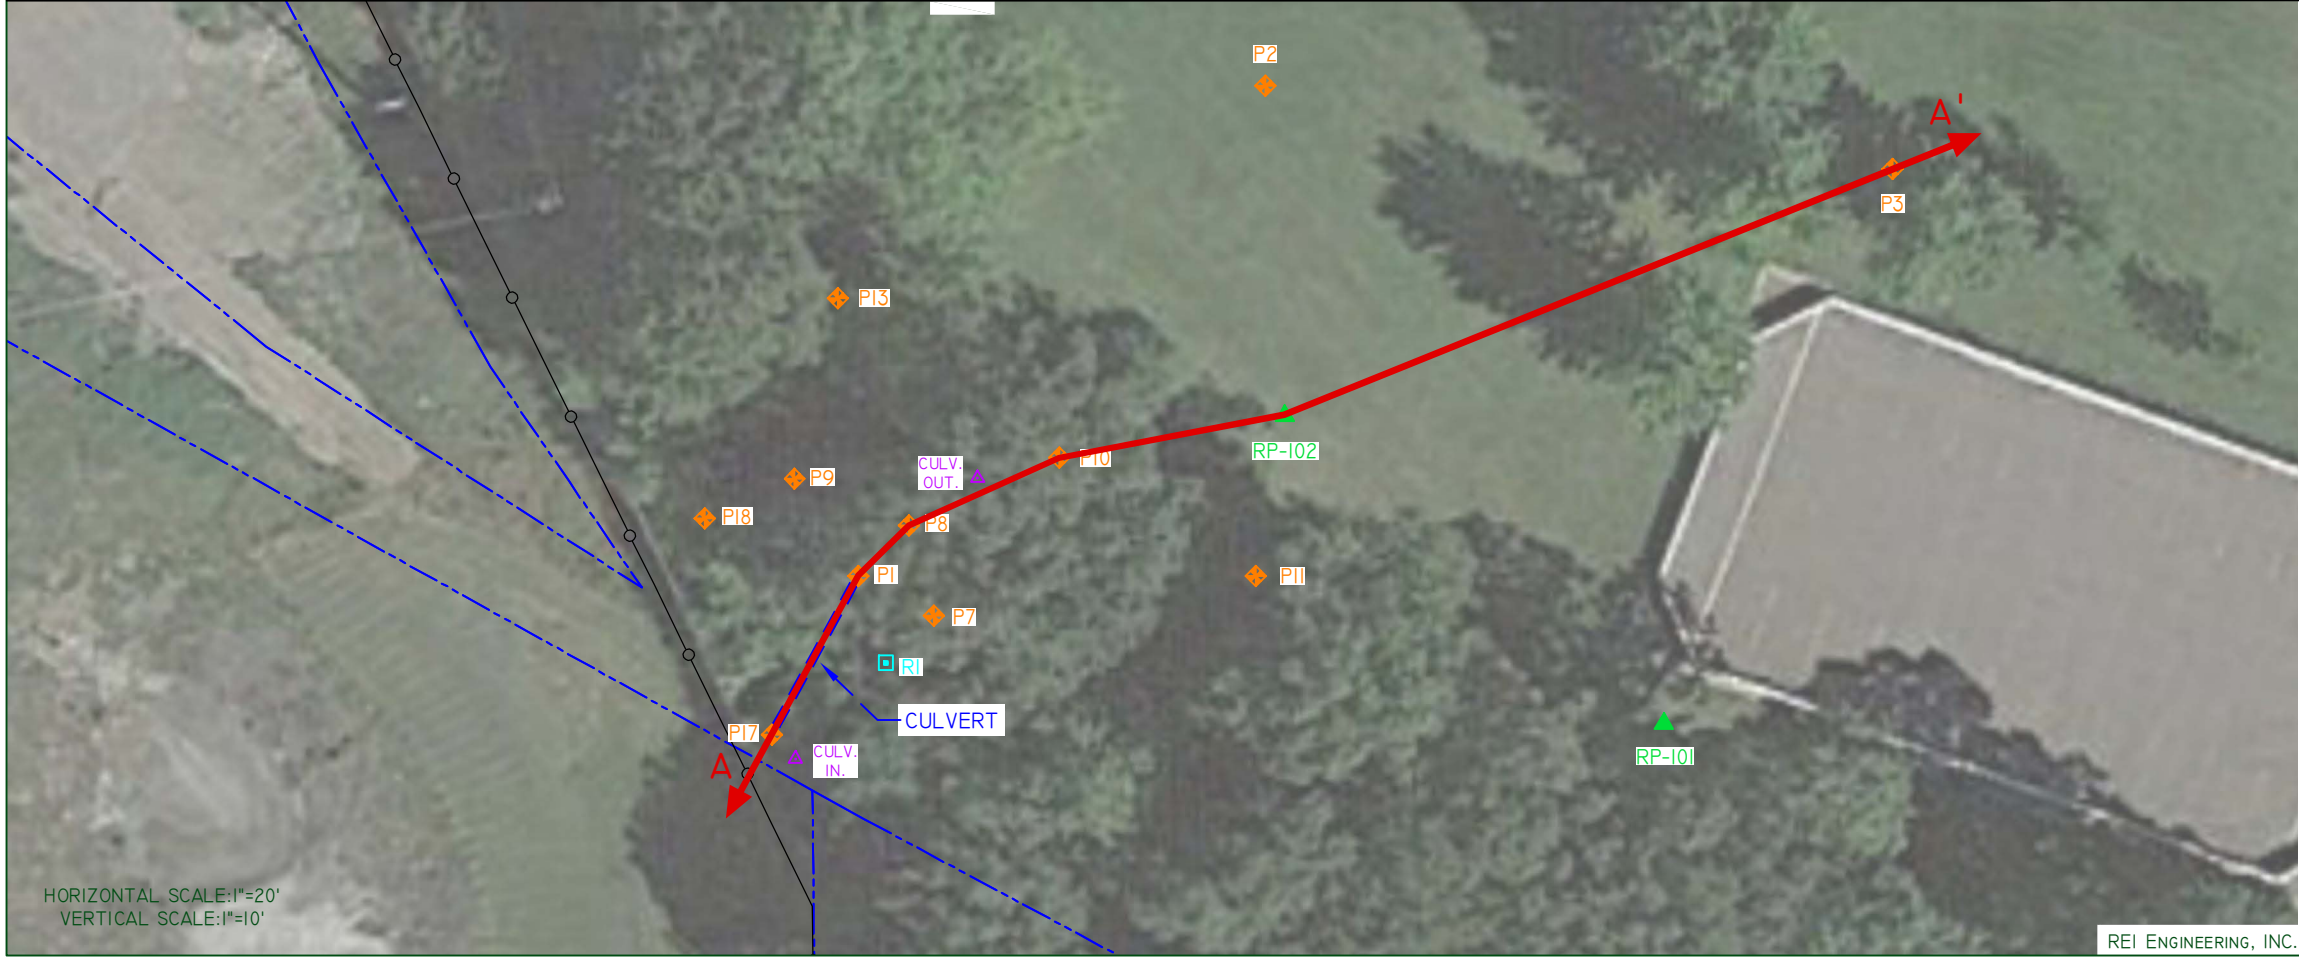
DRAWING FILE: P:\9000-9099\9073 - CITY OF WAUSAU RIVERSIDE RR CORRIDOR\dwgs\9073-X SECTION.DWG LAYOUT: X-SECTION PLOTTED: SEP 13, 2021 - 2:16PM PLOTTED BY: MATTM

HORIZONTAL SCALE: 1"=20'  
VERTICAL SCALE: 1"=10'

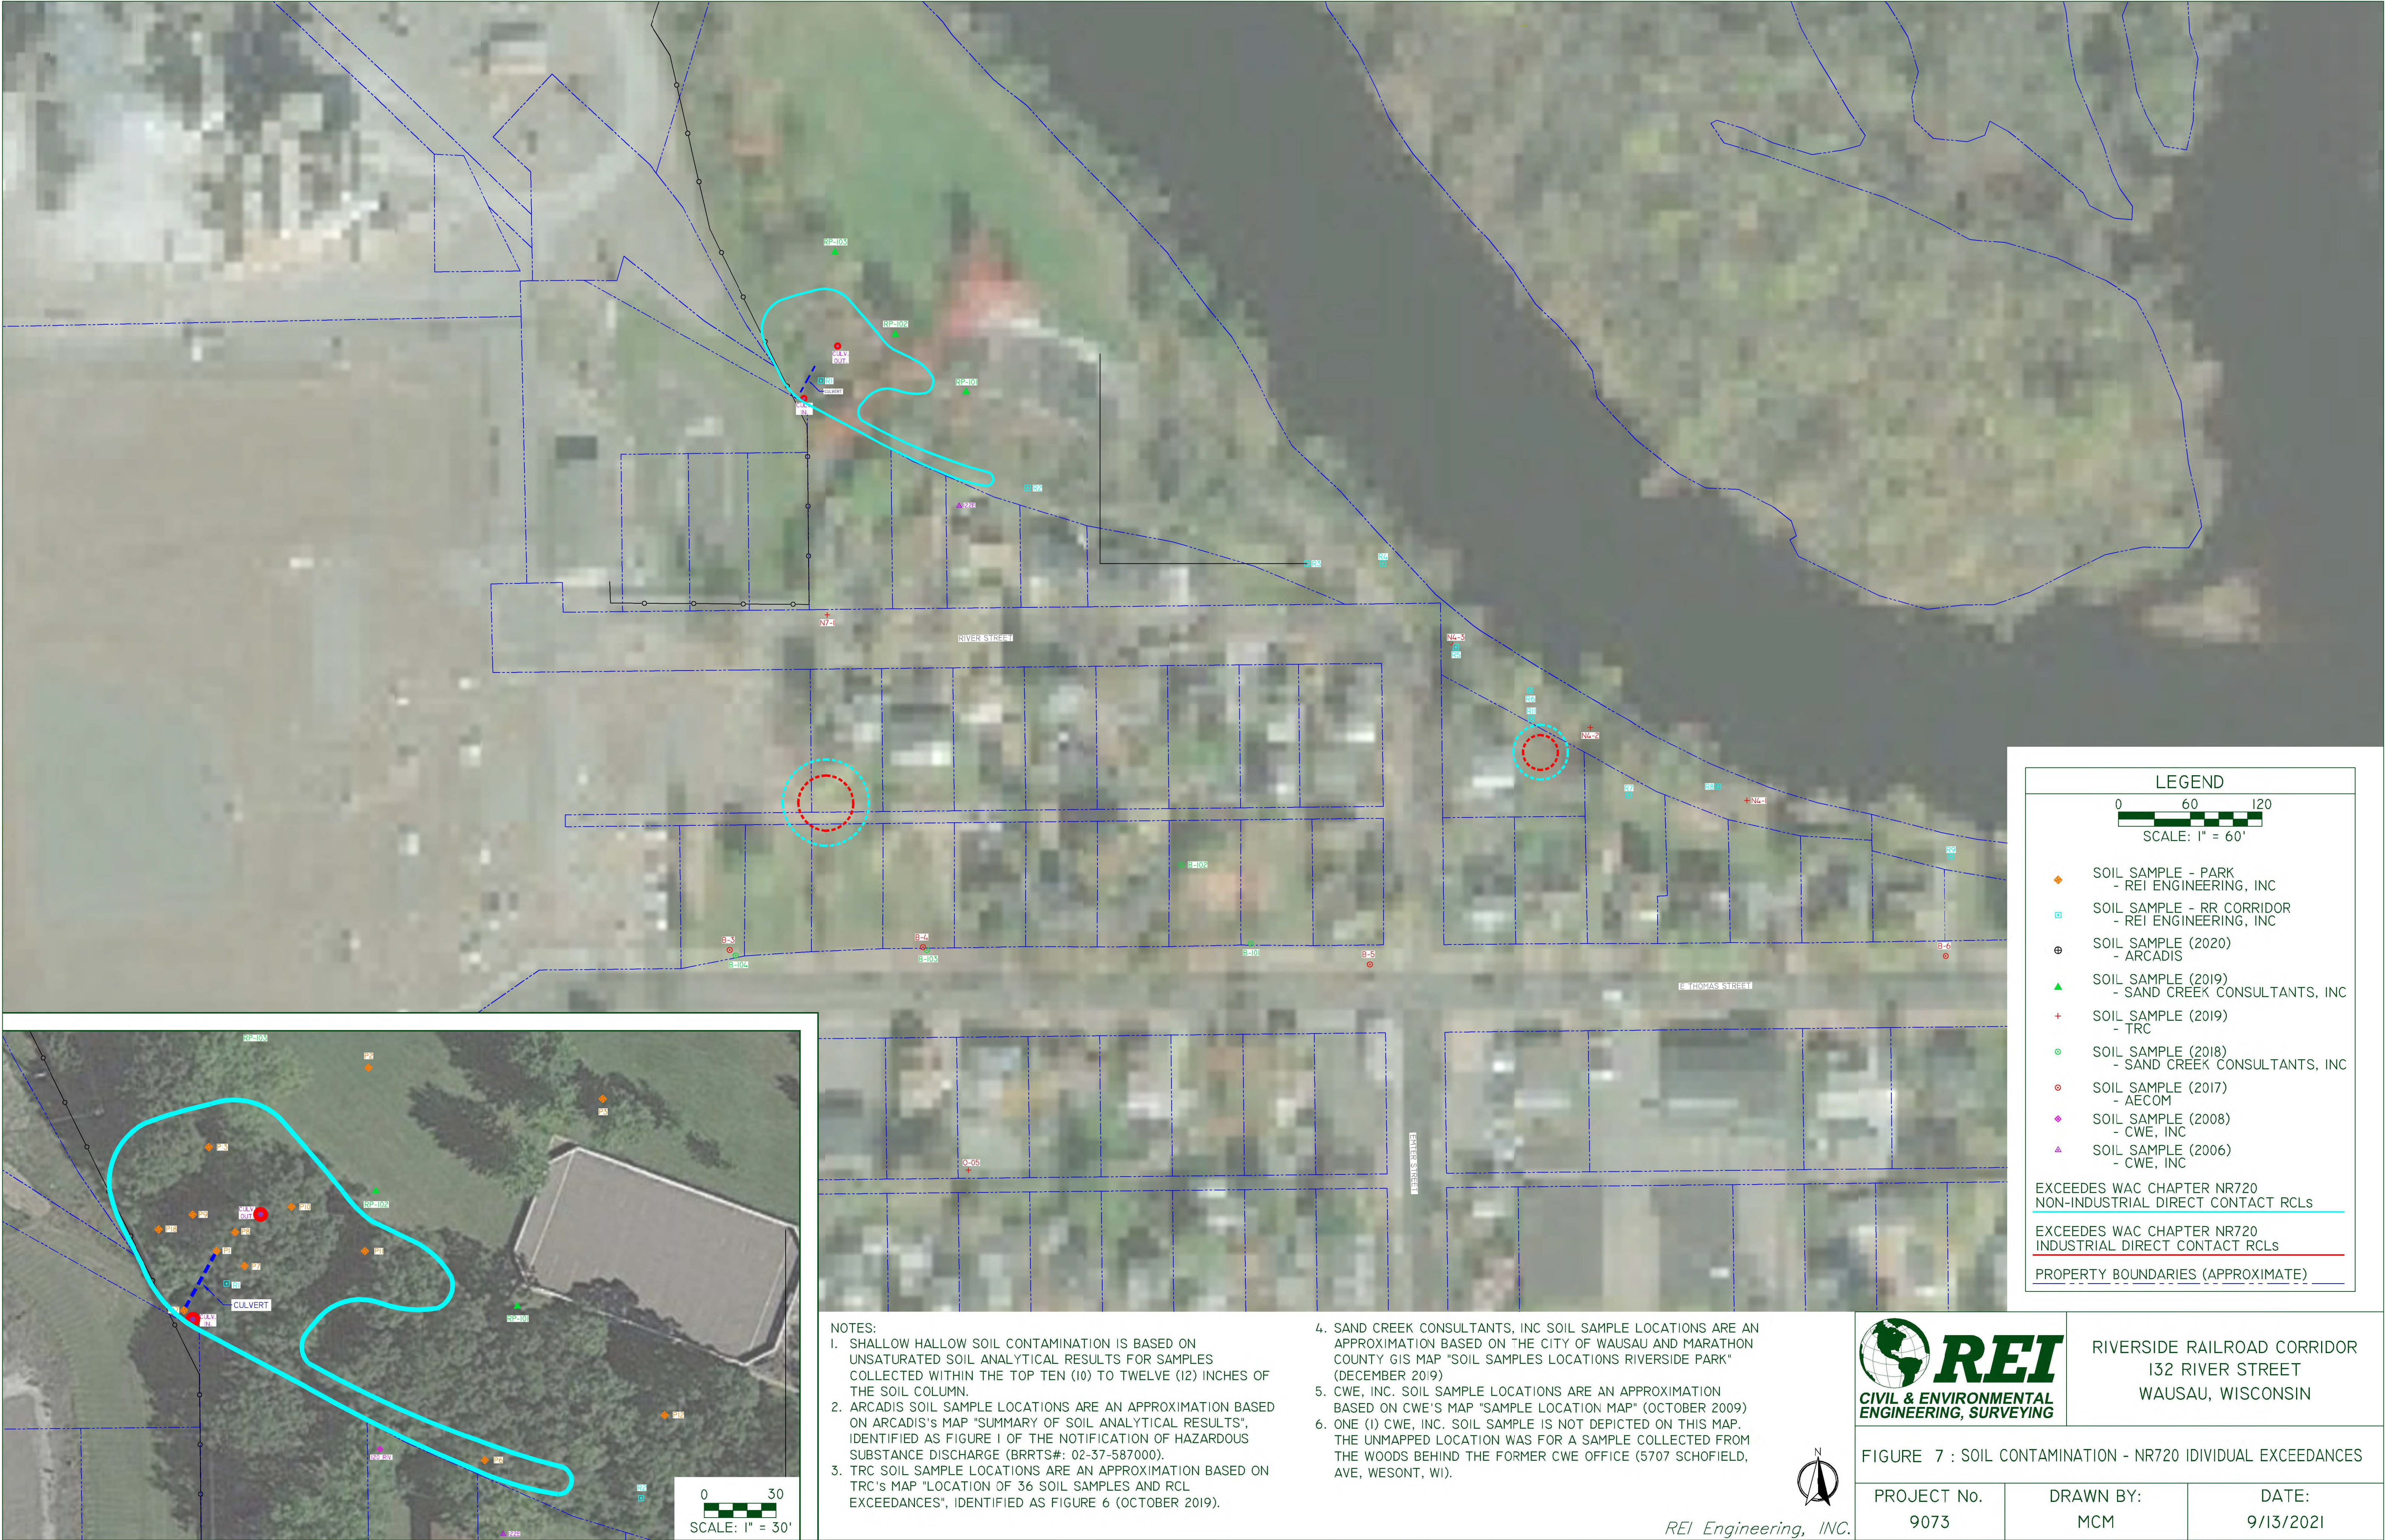
DRAWING FILE: P:\9000-9099\9073 - CITY OF WAUSAU RIVERSIDE RR CORRIDOR\DWGS\9073-Soil CONTAMINATION-NR720.DWG LAYOUT: SITE (24X36) PLOTTED: SEP 13, 2021 - 2:22PM PLOTTED BY: MATTM

Three (3) soil samples identified WAC Chapter NR720 Non-Industrial Direct Contact RCL exceedances for the calculated cumulative hazard index including: Culvert In (4-6 inches bls), Culvert Out (4-6 inches bls), and N4-3 (0-6 inches bls).
